**HEAVY MOVABLE STRUCTURES, INC.
TWENTIETH BIENNIAL SYMPOSIUM**

**Gear Couplings: Design, Maintenance, and
Inspection Lessons Learned from Past
Issues**

Adrian E. Soltys, PE.
Wiss, Janney, Elstner Associates, Inc.

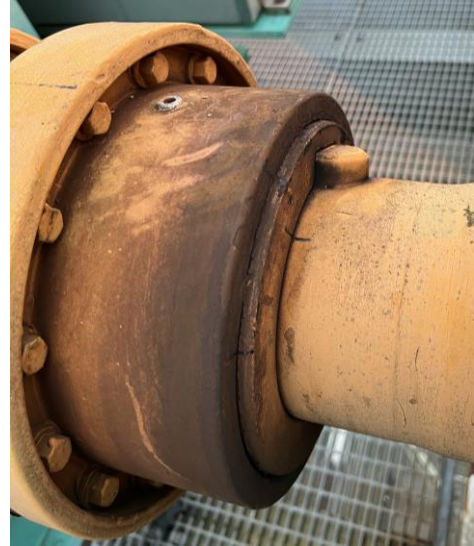
The initial challenge was twofold: identify what failed and take steps to safely lower the span to reopen to traffic, and then assess the extent of collateral damage and develop immediate repairs restore operation of the lift span. Mechanical engineering/inspection personnel responded on an emergency basis as part of a team with a bridge industry Contractor to assist in this initial effort. A remote visual inspection of the machinery via videoconference was performed. This inspection identified several line shaft couplings with external evidence of internal corrosion. See Figure 1. A coupling failure was immediately suspected.

Figure 1: Coupling immediately after failure. Note fretting on exterior of the coupling sleeve, indicating internal corrosion of the coupling.

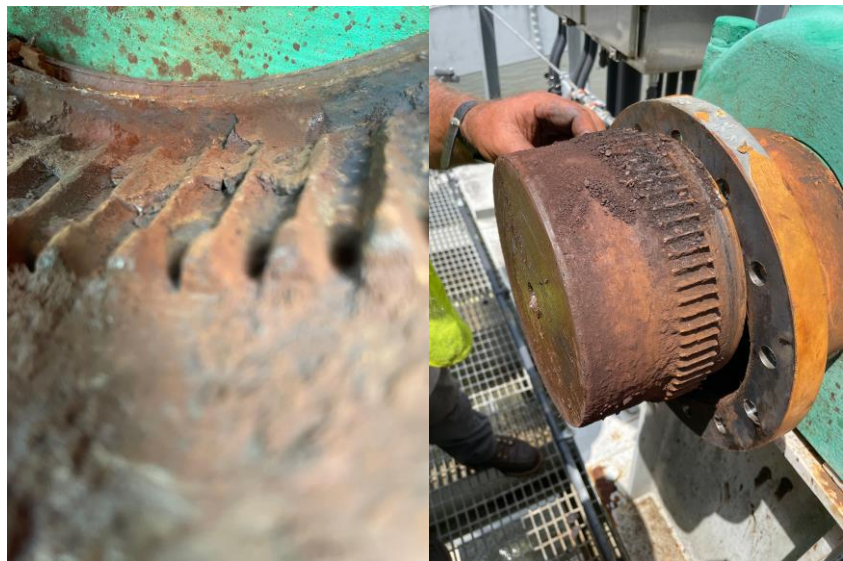
A plan was developed to utilize a barge mounted crane to raise the end of the span that failed in order to level the span out. During this process the line shafting was observed and the location of the failed coupling was confirmed. The span was then lowered slowly and incrementally, using the crane at one end and the span drive machinery at the other end. This was completed within 18 hours of the initial failure, just as the mechanical engineering/inspection personnel were arriving at the site. The next morning, damage assessment and evaluation commenced. The failed coupling was disassembled, and inspection was performed to determine the cause of the failure. It was found that the coupling gear teeth were severely deteriorated due to wear and corrosion. No grease was present within the coupling. See Figures 2 and 3.

Figure 2 (Left, Sleeve) and 3 (Right, Hub): Inspection of the failed coupling. Note lack of grease, excessive corrosion and wear present.

In order to return the bridge to service, a temporary fix was proposed to allow time for procurement of a new coupling for a permanent repair: weld the coupling sleeve to the coupling hub around the circumference of the sleeve-hub interface. This would effectively transform the flex-flex coupling into a flex-rigid coupling. Prior to proceeding with this course of action, the alignment of the coupling was measured and it was determined that the coupling was very well aligned. It was decided by the Owner that welding was an acceptable temporary repair and the work

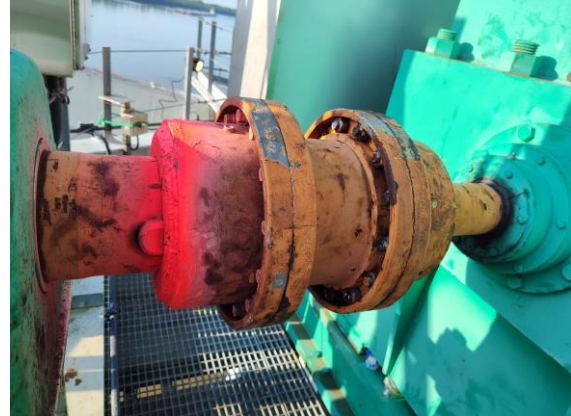
Figure 4: Weld was placed at the hub-sleeve interface of the failed coupling, marked in pink.

was executed by the Contractor, photographed in Figure 4. The lift span was authorized to be operated at a reduced speed and a reduced frequency of operation to limit the number of cycles on the weld and remaining line shafts/couplings.

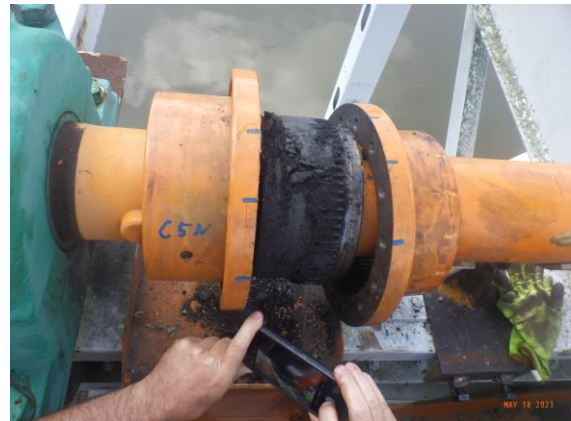
Figure 5: Coupling immediately after disassembly. Note hardened grease covering gear teeth.

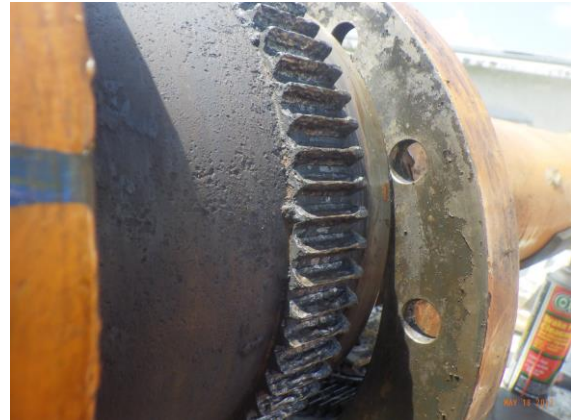
Figure 6: Coupling shown in Figure 5, after grease debris was removed. Note heavily worn and degraded gear teeth.

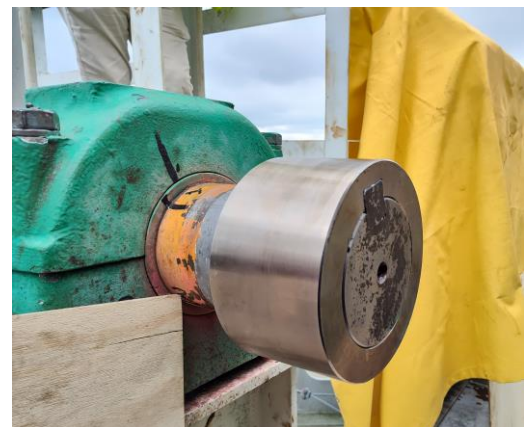
7. The shafts were cleaned and checked with the custom sleeve. It was discovered that each shaft and keys needed to be dressed up with sand-paper and flat stones before the sleeves were able to be installed with ease. See Figure 7 for a photo of the custom sleeve hub shown placed over the dressed-up shaft.

Figure 7: Custom coupling sleeve slid over the shaft, indicating the new coupling hub may be installed.

5. Custom shaft sleeves were manufactured to mimic the diameter and key locations of the coupling hubs after they were to be heated. These custom sleeves were used as a “go/no go” gauge prior to attempting to install the new coupling hubs. If these sleeves were able to be installed onto the shaft and keys at ambient temperature, then the coupling hubs theoretically would be able to be installed when heated.

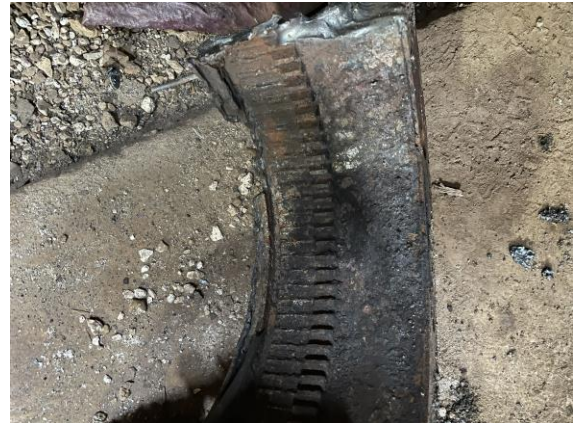
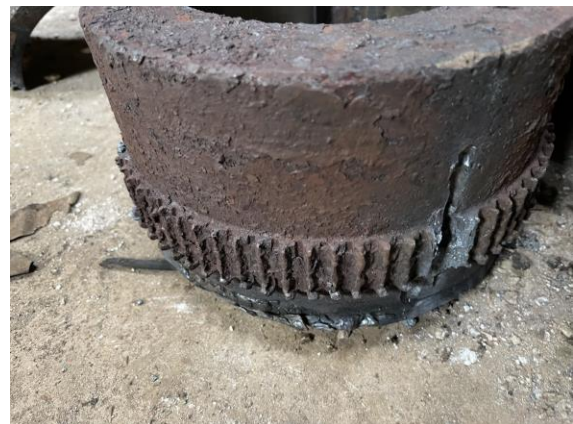
Emergency work was authorized after the coupling failure to return the machinery back into service as quickly as possible after the coupling failure. All couplings were disassembled for internal inspection. It was discovered that 3 of the 4 couplings contained adequate amounts of grease, while the remaining coupling did not appear to be greased. The non-greased coupling was the unit that experienced the failure. The failed coupling showed wear and corrosive damage to the gear teeth, which were no longer able to mesh and transfer torque. Figures 8 and 9 show photos of the internal condition of the failed coupling.

Figures 8 & 9: Photos showing the internal condition of the failed coupling. Note excessive wear and corrosion on gear teeth, with similarity to couplings shown in Case I. Also shown burn marks were inflicted during coupling disassembly from shaft.

Procurement for a replacement coupling hub proceeded immediately after the coupling failure. It was found that a stock replacement coupling hub that was finished bored and keyed was immediately available from a warehouse. A review of the tolerances for this coupling found that while the fits for the bore and key were not 'per Code', they would meet the requirements of the coupling manufacturer. The ability of using the stock bore size of the coupling greatly reduced the total duration of the outage of the machinery. The new stock coupling was installed and operation of the leaf was restored within 48 hours

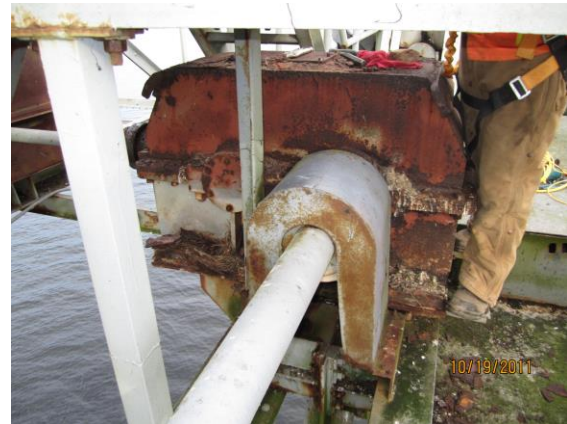
The installation date of the couplings was not available; however, the couplings could have been in service for as long as 55 years prior to experiencing catastrophic failure in 1 of 16 couplings. Similar to the previous two cases, the coupling failed in such a way that neither rotational movement nor torque were transferred from the coupling hub to the coupling sleeve. As the machinery system was operating, the coupling hub appeared to be rotating within the stationary sleeve as the internal coupling gear teeth were unable to mesh. It was noted during the inspection efforts that the metal covers over the shafts and couplings were difficult to remove, and the couplings were difficult to access for maintenance purposes, shown in Figure 10.

Figure 10 (above): Photograph showing coupling obscured by its protective cover.

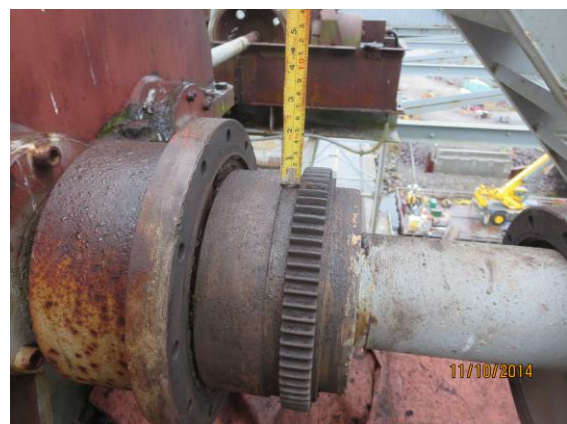
Inspection of the remaining couplings was undertaken immediately after the failure. The couplings were disassembled and were found in various stages of deterioration. Most couplings had issues of corrosion and excessive wear due to lack of lubrication and moisture intrusion. The couplings that only had light corrosion, and whose teeth appeared to be in good condition, were left in service. Otherwise, couplings that exhibited corrosive pitting, a battered appearance, any damage on the coupling gear teeth, were replaced (Figure 11).

Figure 11: Photograph showing coupling with corrosive damage to be replaced.
