RESTORING AN ICONIC PART OF THE FORT LAUDERDALE SKYLINE:

BROWARD FINANCIAL CENTRE, A 2022 TRINITY AWARD WINNER

BY KAREN K. ZIMNICKI, RA, NCARB, LEEP AP
Wiss, Janney, Elstner Associates, Inc., Associate Principal

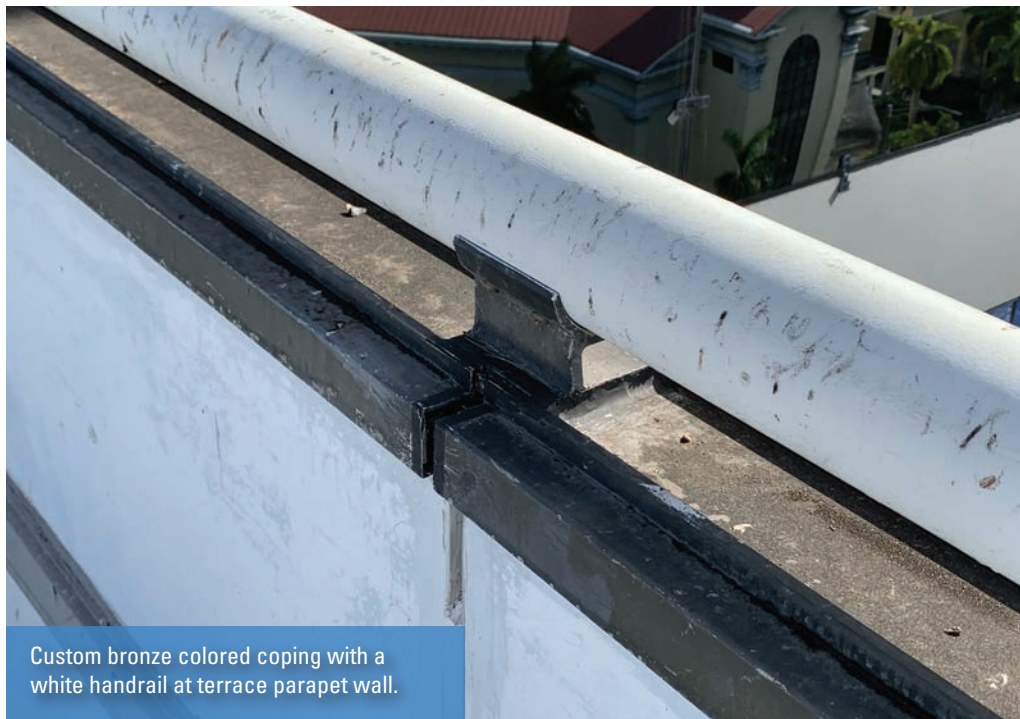
Custom bronze colored coping with a white handrail at terrace parapet wall.

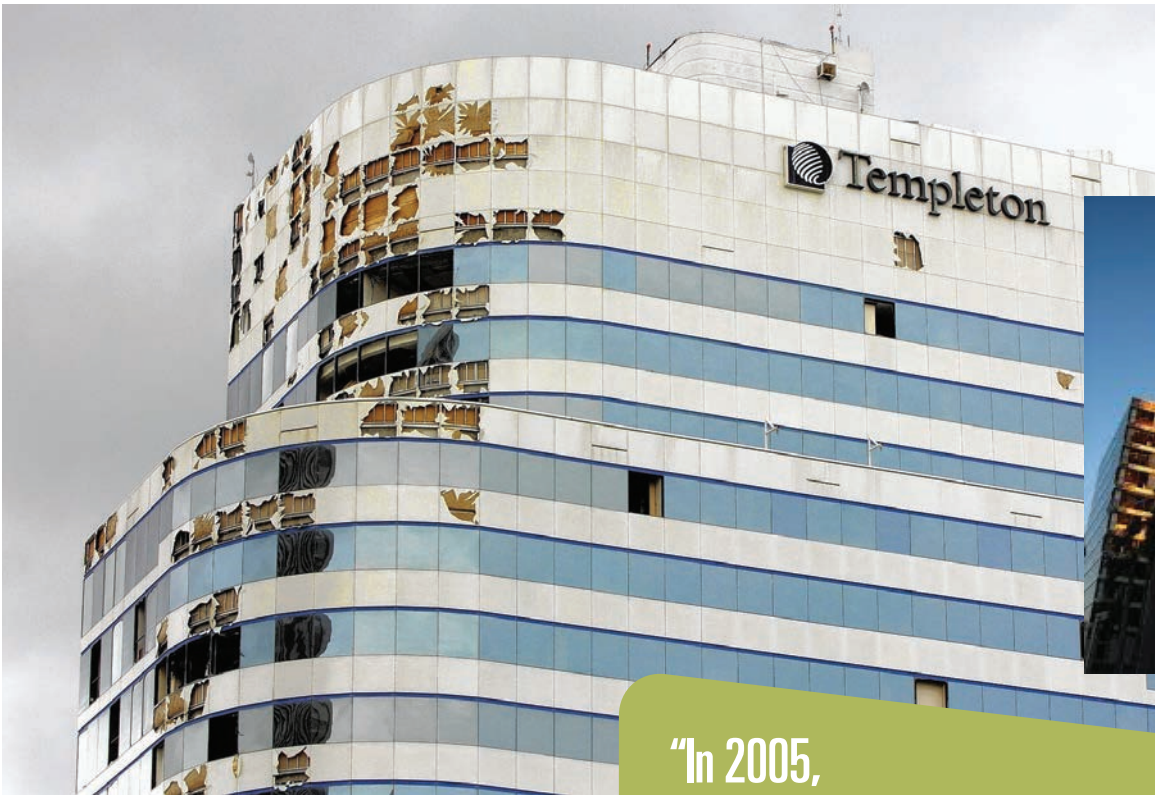
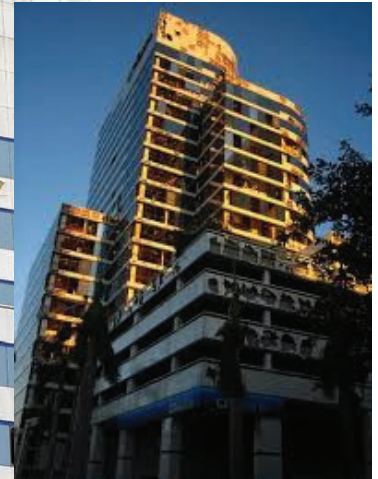
In 2005, approximately 19 years after construction, Hurricane Wilma destroyed a significant number of curtain wall glazing lites and façade panels on the Broward Financial Centre façade. Historic photographs of the building damage were showcased in the news. Repairs by others following the hurricane included replacing original opaque/coated glass panels with aluminum composite material (ACM) panels. While the ACM panels allowed the building to return to a serviceable condition, they later played a challenging role in the subject repair project.

Left and Below:
Damage from
Hurricane Wilma
in 2005.

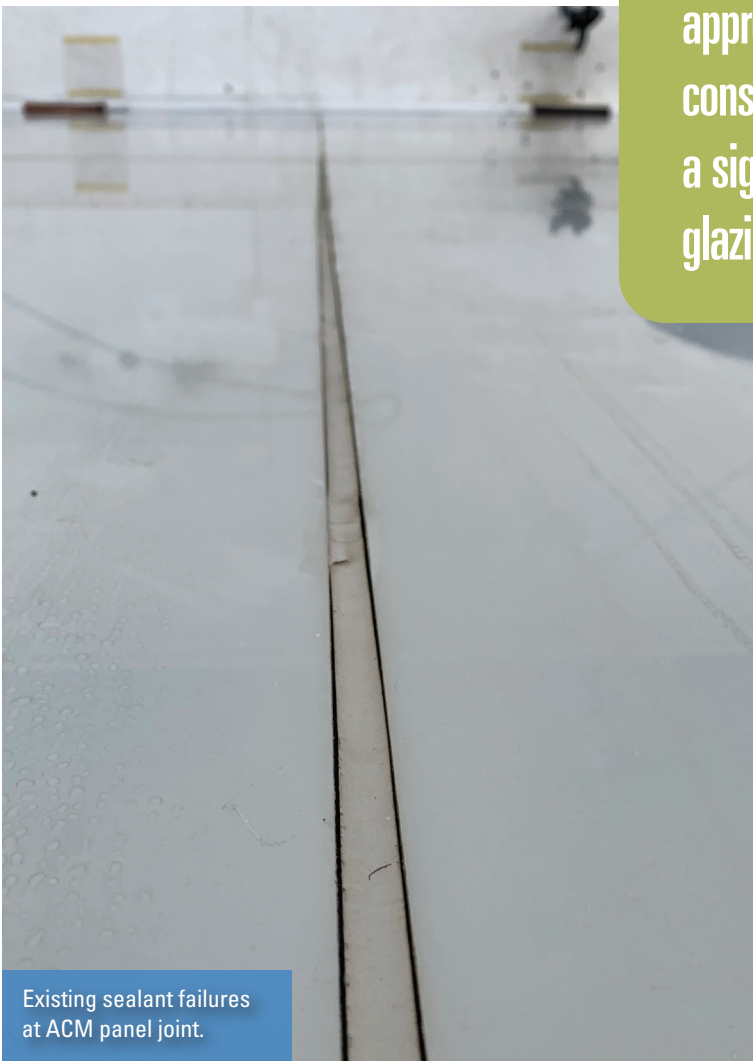
Existing sealant failures
at ACM panel joint.

The design and construction of the sealant and coating repairs presented many opportunities to problem-solve technical and logistical challenges. The ACM panels that were installed following Hurricane Wilma had plastic cores exposed at the perimeter of the panels, which did not allow for sealant bond if traditional hourglass-shaped sealant joints had been installed within the panel joints. Existing sealant bond failures were prevalent at ACM panel locations. Due to the panel edge condition and lack of proper bond surface to the metal, the design of the repairs included preformed silicone extrusions over the existing panel sealant joints. Not only did the

panels would have required replacement. To save cost, the team chose to leave the existing ACM panels in place and preformed silicone extrusions were installed over the joints.

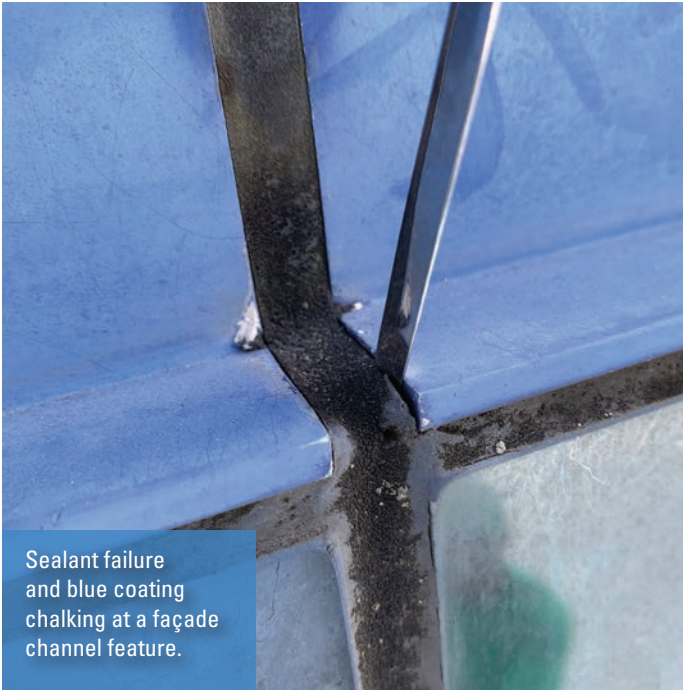
Sealant failure and blue coating chalking at a façade channel feature.

Prior to the repairs, the existing blue coating on the exposed aluminum channels at the head of the curtain wall assembly was chalking and running down the façade. The chalking coating was found to limit the bond of the new sealant and the painted substrate and required removal in order to create a suitable substrate for the sealant repairs. Although this condition was not originally anticipated, the owner team elected to install a new blue high-performance coating on the channels prior to resealing after the project team educated them on the impact the chalking paint would have on the durability of the sealant repairs.

- Removal of the existing blue coating on the aluminum channels and recoating with a new high-performance coating. Through trials, the project team chose to implement chemical paint stripping to remove the chalking blue paint in lieu of mechanical abrasion. This methodology ultimately saved cost, eliminated damage to adjacent materials, and lessened disruption to building occupants and the public, which could have occurred due to the high activity and windy conditions of the downtown area.

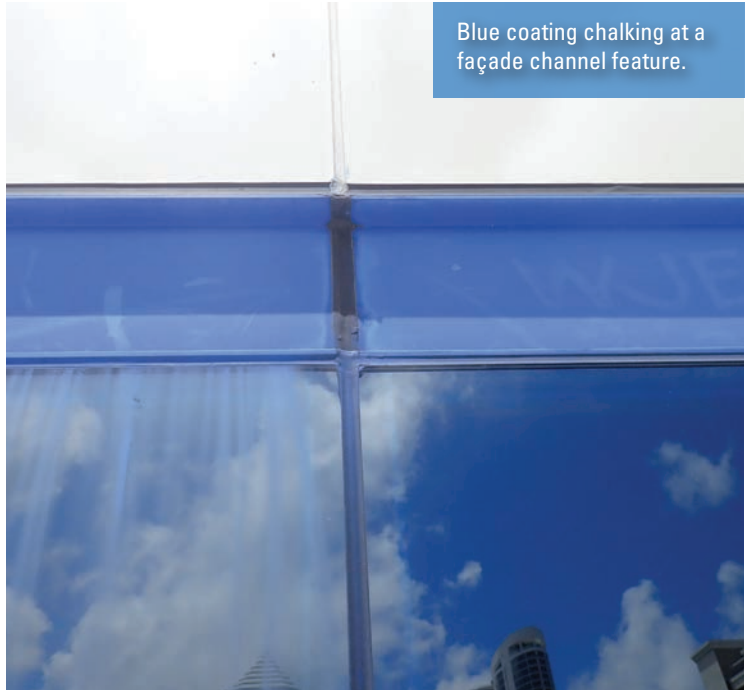
Blue coating chalking at a façade channel feature.

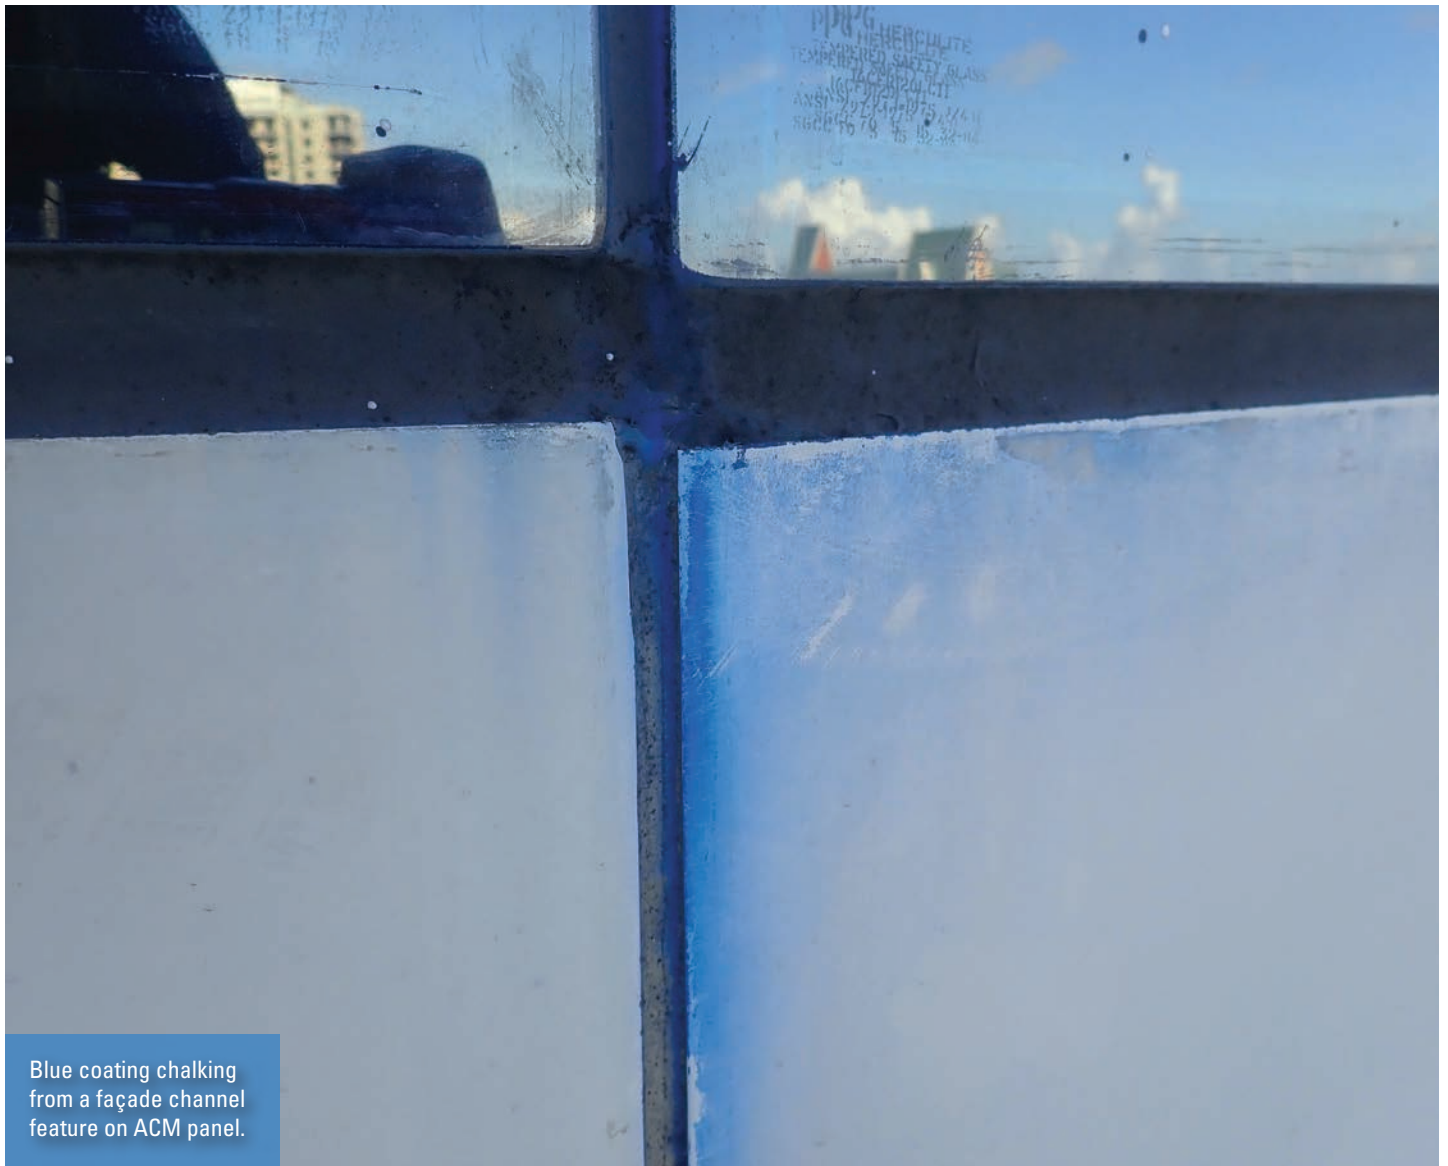
Blue coating chalking from a façade channel feature on ACM panel.

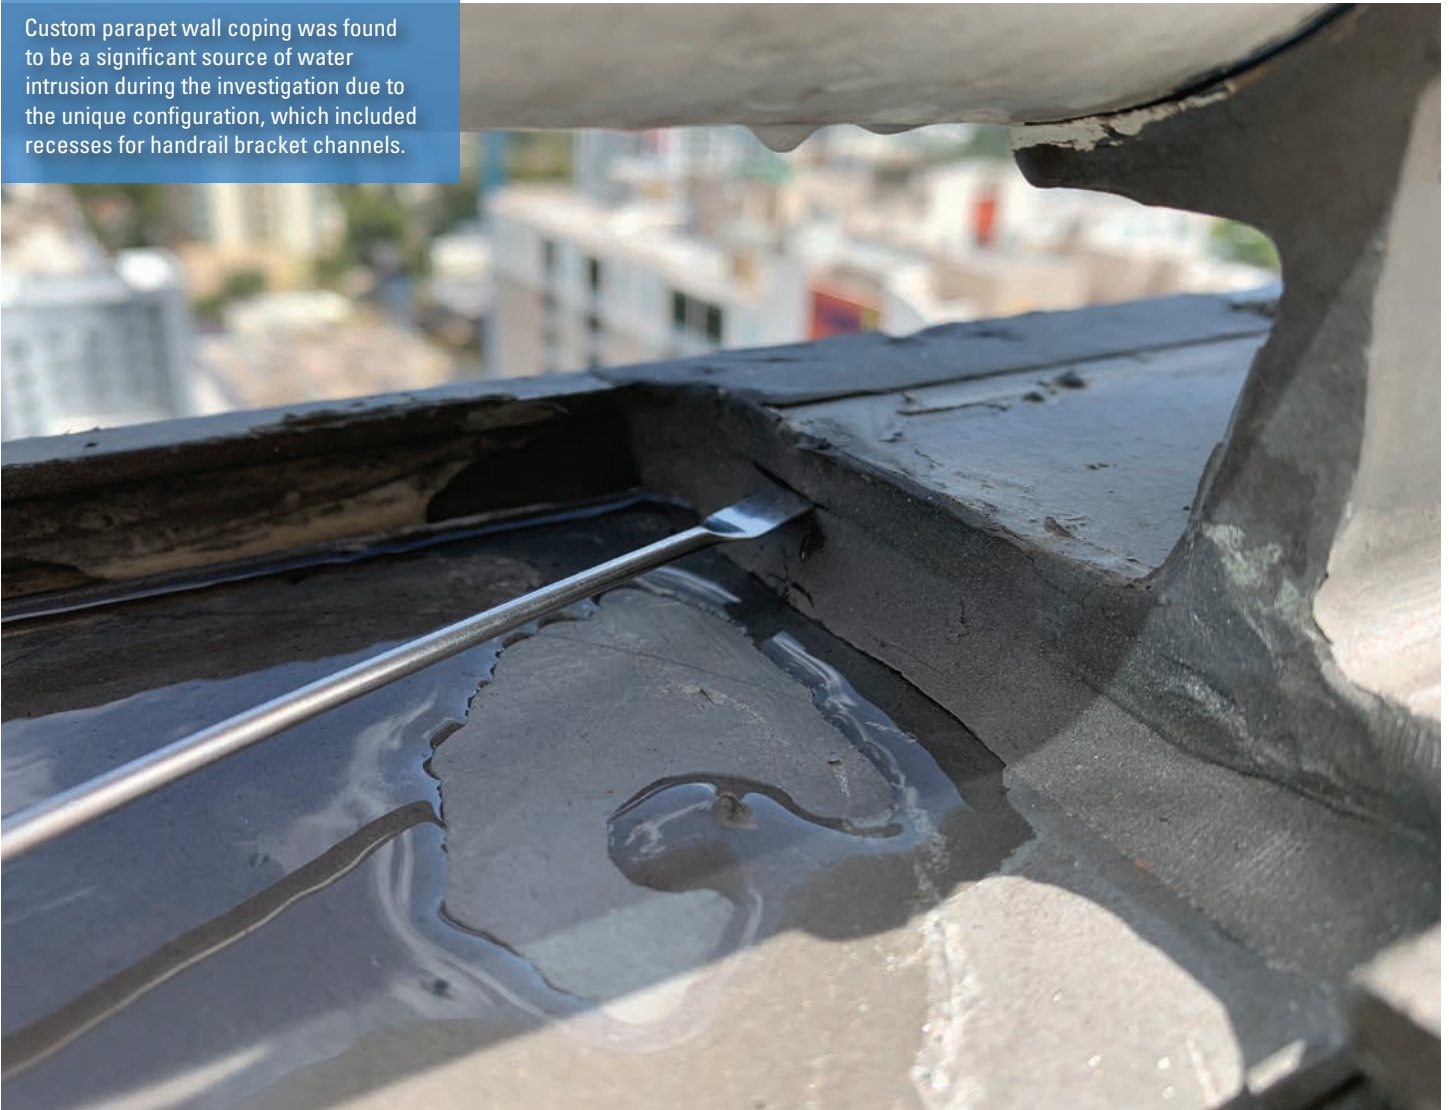
Custom parapet wall coping was found to be a significant source of water intrusion during the investigation due to the unique configuration, which included recesses for handrail bracket channels.

The decorative, custom parapet wall coping was found to be a significant source of water intrusion during the initial investigation. This was due to the unique configuration, which included recesses in the top of the coping for handrail bracket channels that were difficult to seal and maintain. The owner was presented with several options,

- Removal of the existing handrails and brackets on the building parapet walls and installation of new wood blocking and prefabricated sheet metal coping over existing coping. New parapet copings (capable of meeting Florida’s progressive high wind load structural requirements) were installed on top of the existing custom coping by removing the rail and leaving the coping in situ. Following analysis, the existing custom copings were allowed to remain in situ, serving as a substrate for the new copings and maintaining the building in a watertight condition during construction. The new coping system simplified the waterproofing/sealing for ease of future maintenance.
- Preparation and recoating of existing copings and railings on the parking garage parapet walls.
- Installation of new TPO roofing over aluminum-faced plywood panels at the inner faces of parapet walls.
