Concrete Rehabilitation Design for the Historic 3rd Avenue Bridge, Minneapolis, Minnesota

by Arne Johnson, Tanner Swenson, Dan Enser

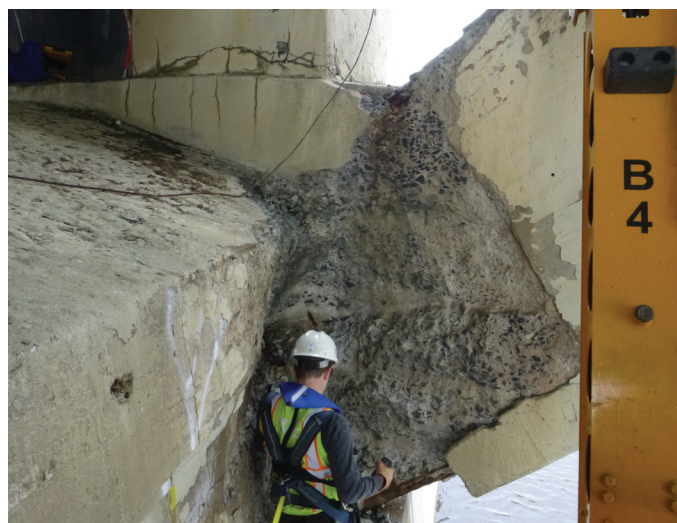
Freeze-thaw damage occurs when non-air-entrained concrete, which includes most concrete constructed before approximately 1950, is saturated with water and while saturated undergoes multiple freezing and thawing cycles. At the 3rd Avenue Bridge, this type of damage was often present below drain discharges or at arch springlines where water collects (Figure 4). Based on petrographic examination of core samples, most of the surface repairs were anticipated to be no more than 6 inches deep, but repair details were provided for depths up to 12 inches, which was the deepest damage observed in the core samples, except for at the pier bases. The contractor is required to excavate incrementally deeper until reaching sound substrate, and payment is on a unit price basis for either 6-inch, 8-inch, 10-inch, or 12-inch depth.

Fig. 4: Deep freeze-thaw deterioration near springline of arch rib below drain discharge (photograph by WJE)

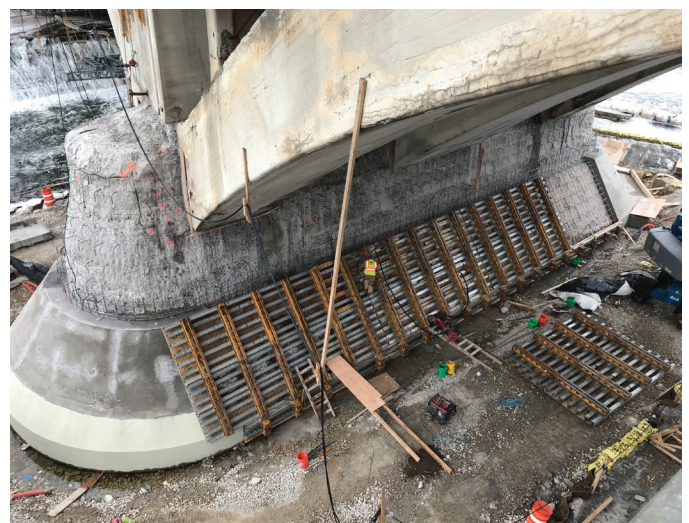
Even deeper freeze-thaw damage was present at the pier bases, near the waterline and below drain discharges. Maximum concrete erosion was up to 17 inches and freeze-thaw damage up to another 8 inches was present beyond that. Rather than removing all the freeze-thaw damaged concrete, the repair details required removal of a uniform 12 inches of concrete to reach what was defined as an “intact concrete substrate” (aggregates firmly embedded in solid paste but some freeze-thaw related cracking allowed), not necessarily a perfectly “sound concrete substrate.” Deeper removals were performed in localized “pockets” to reach an intact surface. Longer epoxy-anchorage were installed deeper into the sound material beyond the removal depth, and a new grid of stainless-steel reinforcement was installed near the surface. New self-consolidating concrete was cast to form a new pier jacket that matches the ornate historic profile of the pier bases (Figure 5).

Fig. 5: Concrete removals completed, reinforcing steel being placed, and new pier jacket concrete being formed and placed (photograph by WJE)

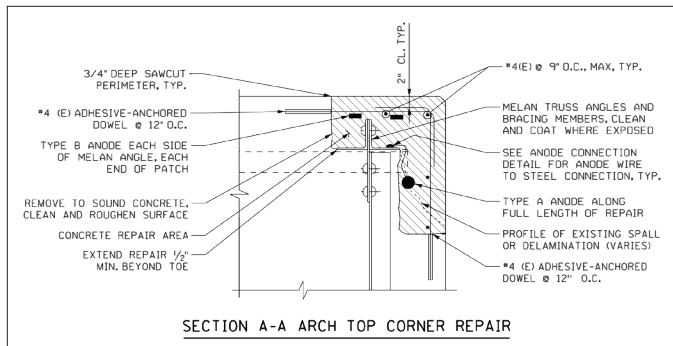
The deterioration in the arches was concentrated at the arch corners where exposure is the worst due to direct runoff and two-side exposure to moisture and freeze-thaw cycling. Corners that were distressed were repaired using a custom detail that included careful reinforcement to control cracking and ensure long-term bond as well as continuous cathodic protection anodes to protect portions of the Melan angles that were not exposed, cleaned, and coated (Figure 6a, Figure 6b). The design team collaborated with MnDOT's engineers regarding potential methods to mitigate future deterioration along the arch corners. After reviewing various approaches together with the owner, it was agreed that, to slow future corrosion damage at segments of the arch corners that were currently sound but

Fig. 6a: Typical detail for arch corner repair where concrete was unsound

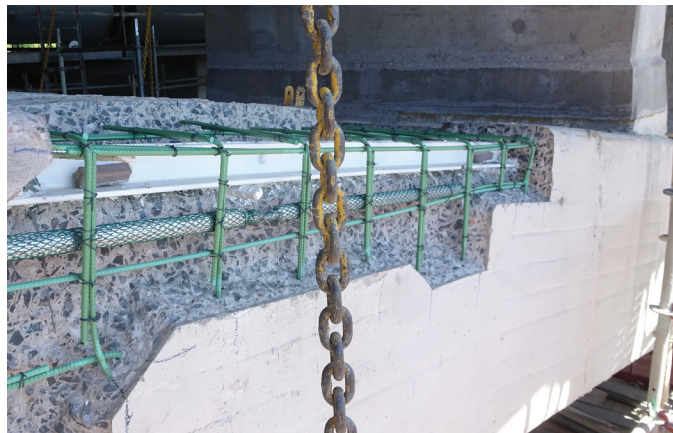
Fig. 6b: Arch corner repair prepared for concrete placement

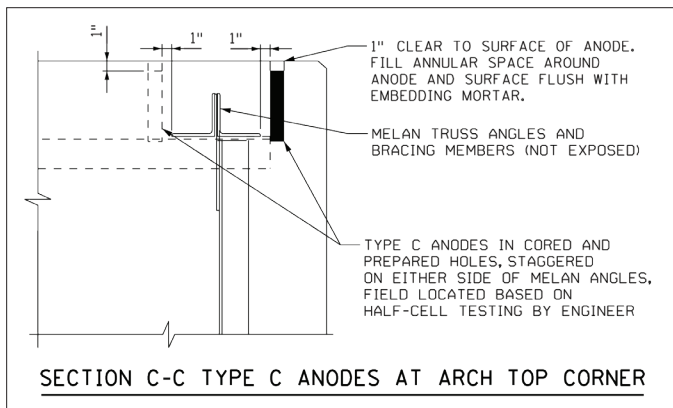
Fig. 6c: Typical detail for arch corner repair where concrete was sound but half-cell testing indicated potential for active corrosion

known to be marginally chloride contaminated and hence vulnerable to future distress, a targeted cathodic protection approach would be implemented. In this approach, cathodic protection anodes would be installed only in areas found, based on testing, to have an elevated risk of corrosion activity. The anodes were specified to be field located based on half-cell potential testing performed during the construction phase in the corner areas between those marked for repair. Where readings indicated potential corrosion activity, anodes were installed in cored holes that were staggered on either side of the Melan angles (Figure 6c, Figure 7). Selected anode locations were wired to test stations for monitoring to verify their effectiveness upon installation and to track their effectiveness at this structure over time.

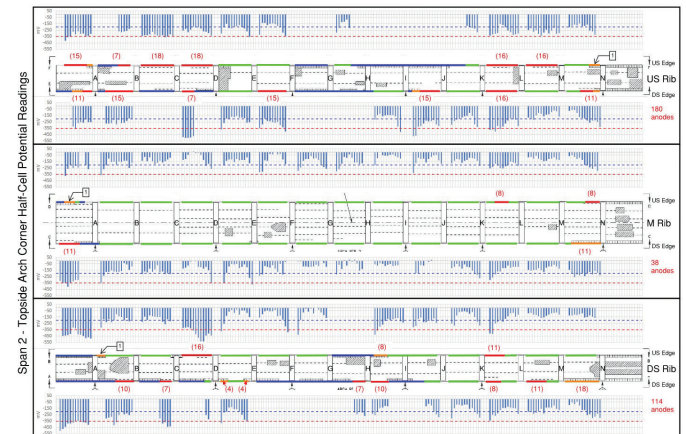
Fig. 7: Example data sheet showing the results of half-cell potential testing to locate the anodes in the zones of sound concrete between the corner repairs (see detail in Figure 6b) (image courtesy of WJE).

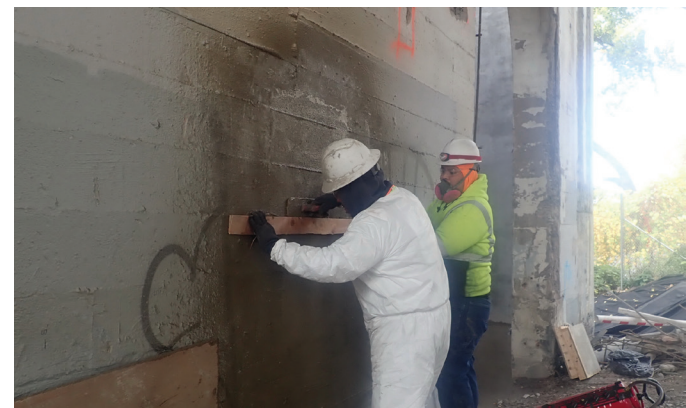
Fig. 8: Example of board-form finish achieved using hand floats in shotcrete surface repair (photograph by WJE).

required in the repairs. To create the board-form texture in the repair concrete, the contractor used form liners for the cast-in-place pier jackets and hand floated the board-form lines into the fresh shotcrete surface repairs to match adjacent areas of remaining original concrete (Figure 8). The project specifications required mockups to be performed in three steps: shop samples, made in the shop and transported to site; field samples, made at the site next to point of placement; and trial repairs, made on the structure and left in place if accepted. This stepwise process provides confidence that the repairs will be historically appropriate and consistent with the specified quality requirements.
