BY **JEFFREY S. LEVINE**  
*Wiss, Janney, Elstner Associates, Inc.*

**Taking a closer look at the causes of metal roof and gutter deficiencies.**

## Up Close: Metal Roofing and Gutters

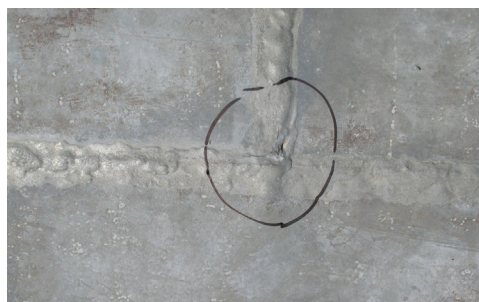
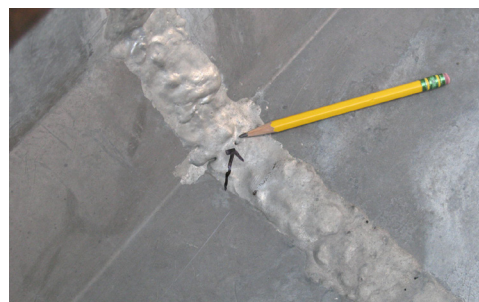
causes of the pictured problems include improper seam selection and design, inadequate accommodation of thermal movement, and poor workmanship (in most cases, failure to sweat the solder all the way through the seam) or some combination of the above.

*The two photos above show a cracked seam viewed from three or four feet up (top) and when viewed up close. The close-up view shows that not only is the solder cracked, but the metal has fatigued and cracked, too.*

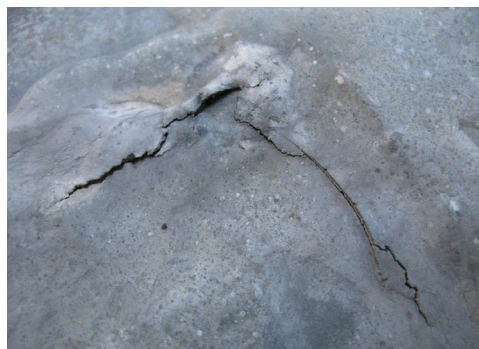
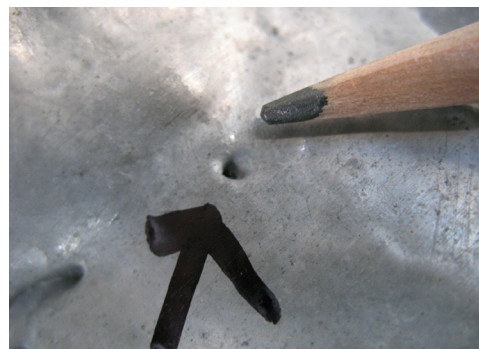
*While surface tension might prevent this open rivet from leaking during a light rain, put a head of water in the gutter and this hole will allow water to pass.*

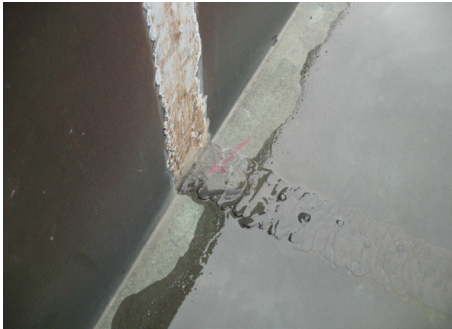
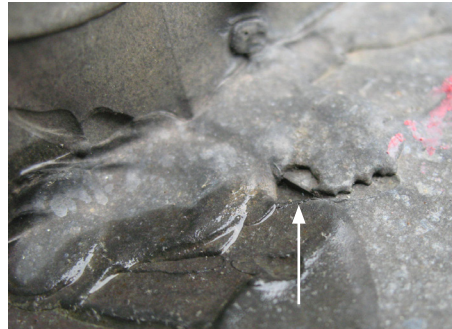
Although the holiday in this lapped, riveted, and soldered seam is only about 1/16" wide, it offers a direct path for significant water entry, especially if the gutter outlet tube should clog and a head of water form.

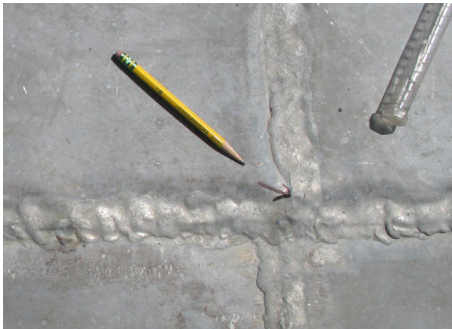
Contrary to industry standards, the locked and soldered seams in this flat seam lead-coated copper roof were soldered using a torch rather than an iron.

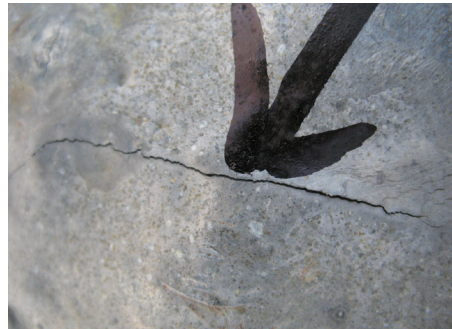
Many of the seams cracked.

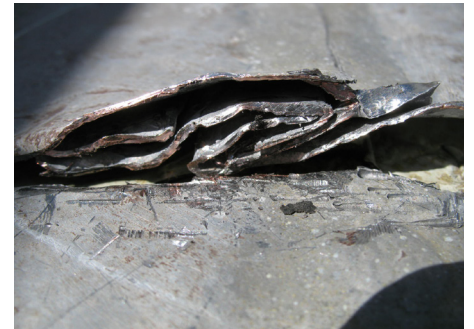
When cut open, it was found that the solder was not sweat through at all. All of the layers (four typically, but six in the photo due to the presence of a cleat) should be completely filled with solder.
