BY **JEFFREY S. LEVINE**
Wiss, Janney, Elstner Associates, Inc.

Up Close: Slate Headlap and Offset

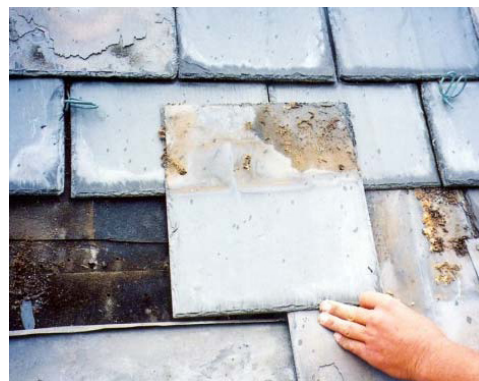
A test opening revealed that slate in the second course had been trimmed—or replaced with shorter, reclaimed replacements—the result of which was no headlap (see photo below)! Rainwater was free to enter the roof system at each and every side joint between slates in the course above.
