# Victory Theatre

Chandelier Wire Rope Failure Investigation and Replacement | Evansville, IN

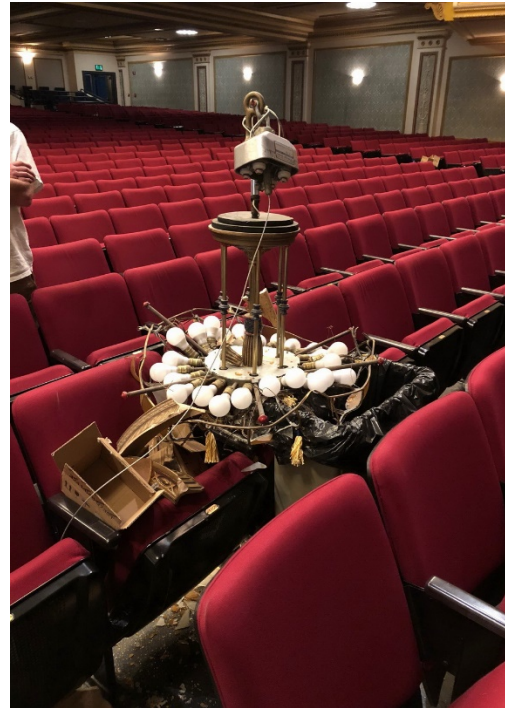
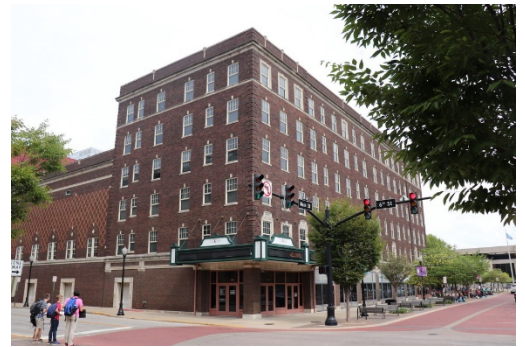
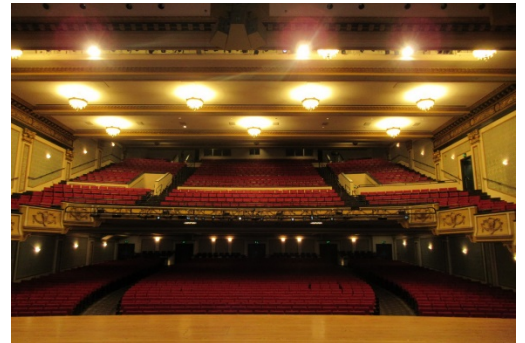
In late September 2018, a 1/8-inch-diameter wire rope hoist cable failed during lowering of one chandelier above the seating area at Victory Theatre in Evansville, Indiana. No one was injured, but the failure caused the historic chandelier to fall and suffer damage. Ten similar chandeliers with similar cable supports remained above the seating area of the theatre.

WJE's investigation included inspection of the remaining ten chandelier hoist cables and preliminary field load testing of one wire rope hoist cable. Testing consisted of loading the loop of the chandelier hoist cable with a load of 500 pounds, which considered the weight of the chandelier and dynamic demands of the chandelier during lowering and raising operation. The existing cable and its end connection sustained the 500-pound test load for the duration of the test; however, after unloading, the change in the measured length of the cable tail suggested that the tail slipped in the compression sleeve during load testing.

WJE then proceeded with examination of the failed wire rope hoist cable with an optical stereomicroscope and a scanning electron microscope. WJE's observations and laboratory evaluation indicated the cable failed when its end pulled out of the compression sleeve that had secured the end of the cable. This mechanism was consistent with the field load testing results. Thus, WJE concluded the hoist cable compression sleeves in their current configuration were unreliable to support the dynamic cable loading that occurs from lowering and raising the chandeliers. WJE recommended replacement of all eleven wire rope hoist cables. WJE designed, fabricated, and proof-tested the replacement cables prior to installation by a local contractor.
