EVALUATION AND REPAIR OF 100-YEAR-OLD CONCRETE STRUCTURES

CAREFULLY CONSIDER MATERIALS, DETAILING, AND HISTORIC CONSTRUCTION TECHNIQUES TO DESIGN APPROPRIATE REPAIRS.

By David Schnerch, Ph.D., P.E.

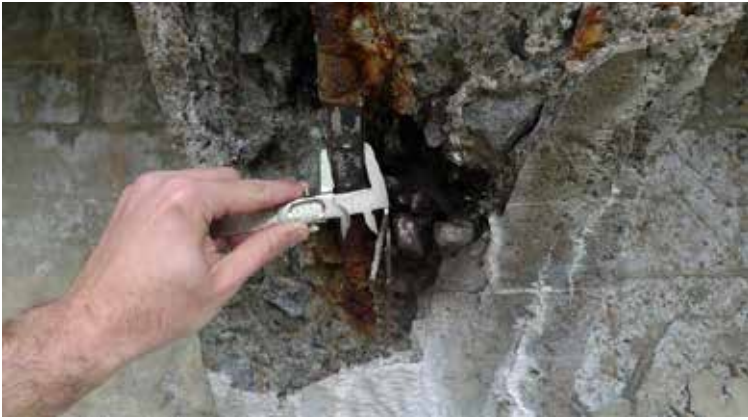
Figure 1: Deformed square cross-section reinforcing bar

Concrete reinforcement became readily available beyond 1900 and specifications for these bars were developed by the Association of American Steel Manufacturers in 1910 and were later adopted by the American Society for Testing and Materials in 1911 (CRSI, 2001). Steel reinforcing was available in round and square bars with deformed round bars available from 1/4- to 1-inch diameter and square bars available in 1/2-, 1-, 1-1/8-, and 1-1/4-inch sizes (Figure 1). Wire fabric of cold-drawn steel and other proprietary systems were also commonly available for the reinforcement of concrete floors.

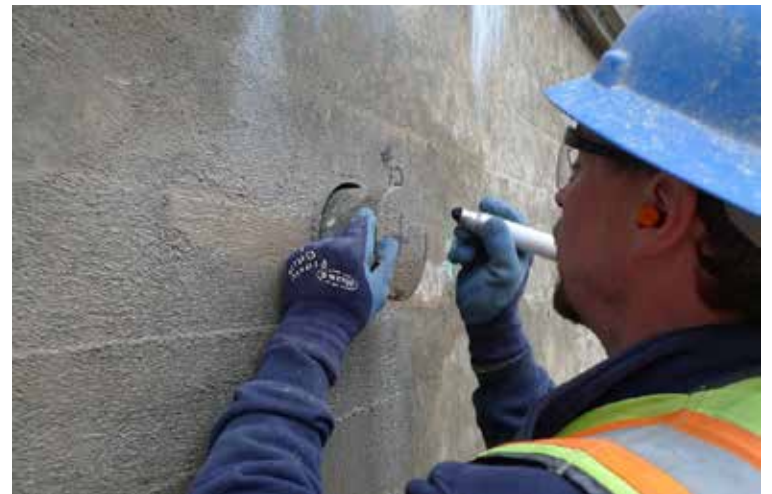
Figure 2: Concrete core sampling for corrosion testing

Concrete cores may be obtained and tested in compression to assess the concrete strength (Figure 2). Minimum values of concrete compressive strengths are provided in ACI 562. Similar information is available to determine the minimum tensile yield and ultimate strength of reinforcing bars. Tensile testing may be warranted if an accurate assessment of the structural capacity is required.
