# U.S. Practice in Vibration Control During Museum Construction Projects

by Arne P. Johnson and W. Robert Hannen, Wiss, Janney, Elstner Associates, Inc., Northbrook, Illinois, USA

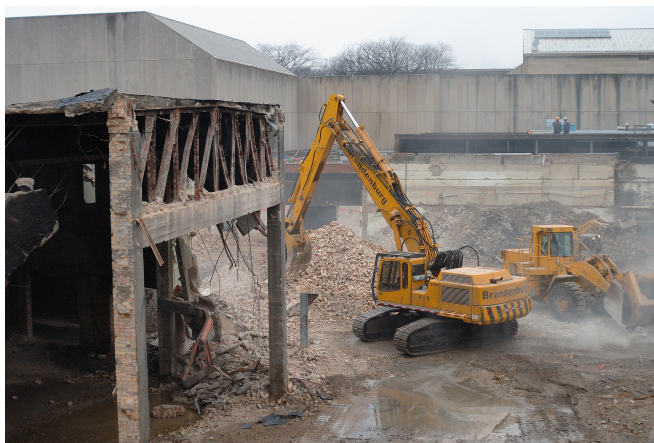
Figure 1: Demolition of existing buildings and buried seawall adjacent to active art galleries at The Art Institute of Chicago

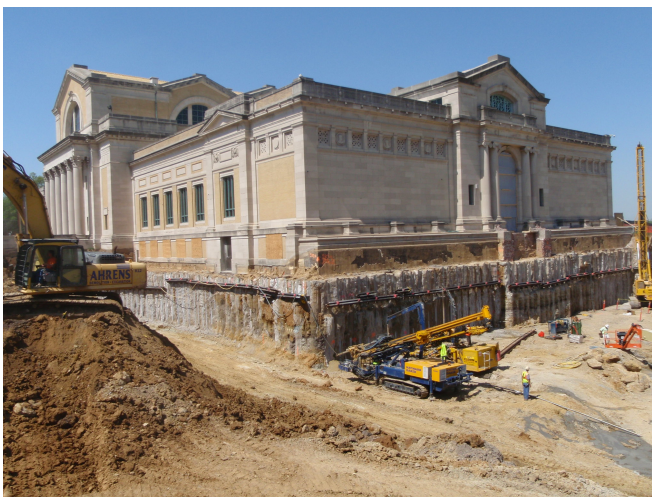
Figure 2: Earth retention system and deep excavation for expansion to The Saint Louis Art Museum, with active art galleries inside museum walls
