BY GARY S. WENTZEL

Wiss, Janney, Elstner Associates, Inc.

Deleterious Expansion of Gypsum-Containing Grout

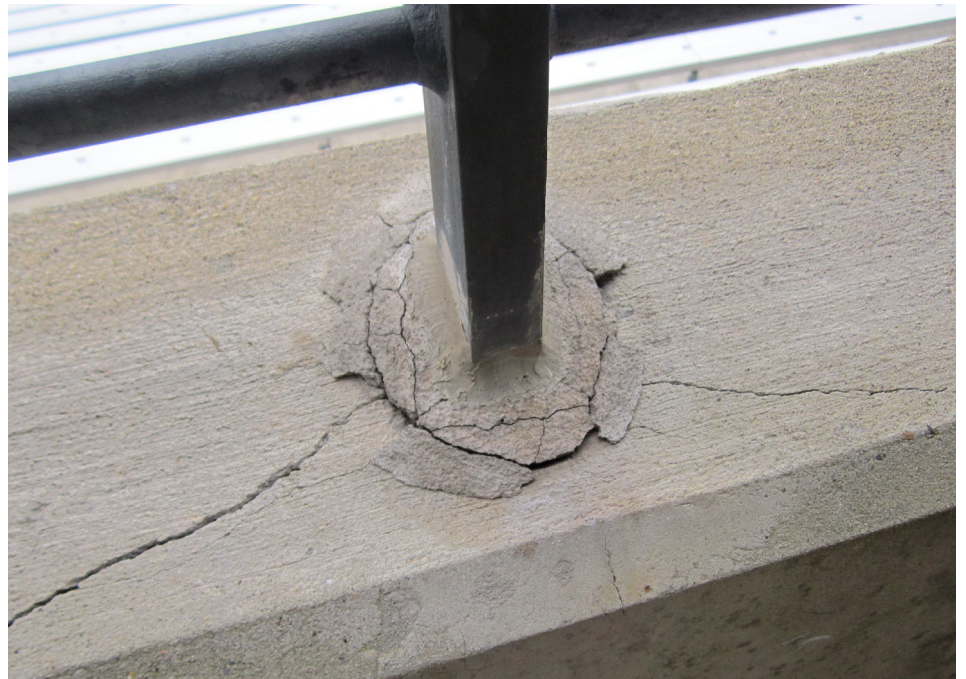
Figure 1.

The expansion of the grout imposes outward forces on the surrounding concrete. Given that unreinforced concrete is relatively weak in tension, the expanding grout can induce cracks in the concrete that radiate outward from the grout pocket. When located along an edge (as railings often are), this cracking often orients itself parallel to the slab, beam, or wall edge (Figure 1). With sufficient expansion and a lack of reinforcing steel near the edge, the deteriorated concrete has reduced capacity to resist rotation of the embedded railing post with an applied lateral force. Eventually, fragments of the slab edge concrete may dislodge and fall from the structure (Figure 2).

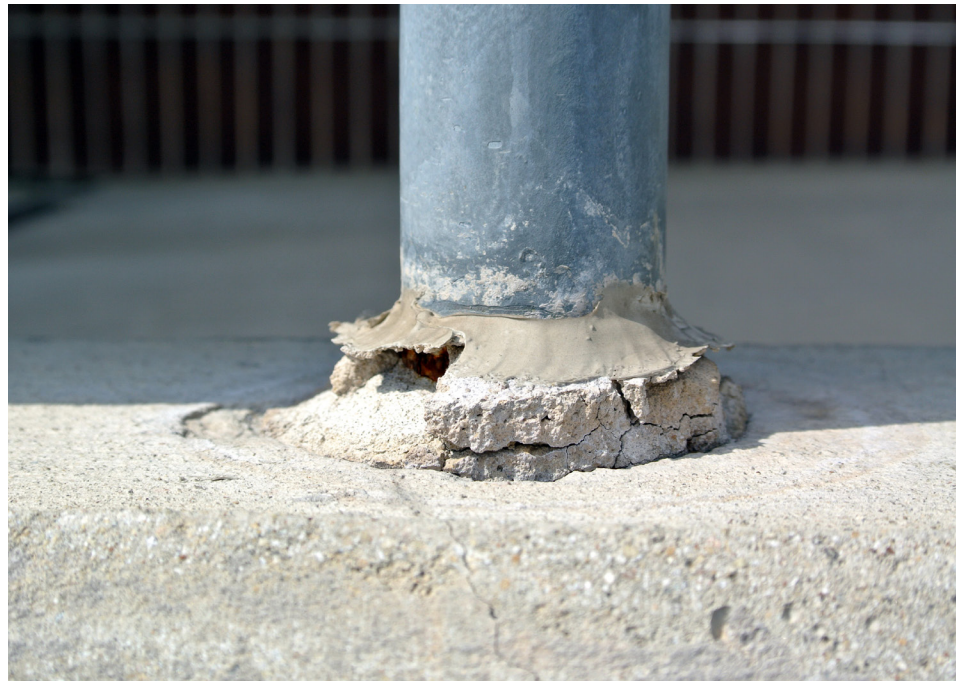
Figure 3.

Volumetric expansion within the grout occurs in all directions: laterally as described above as well as vertically. Because the top of the grout pocket is typically open and unrestrained, vertical expansion within the grout can manifest as upward displacement of the grout (Figure 3) and the railing assembly. Depending on existing geometries and the amount of upward movement, the gap between the railing's bottom rail and the concrete surface may exceed the code-maximum four inches. Top- or bottom-surface spalls in the concrete (Figure 4) can also occur if a strong bond between the grout and pocket wall exists; as the grout expands upward, it drags the adjacent concrete along with it until a fragment of the concrete splits from the top or bottom surface. If the spall is deep enough, it may meaningfully reduce the post's effective embedment depth and thus the capacity to resist rotation.

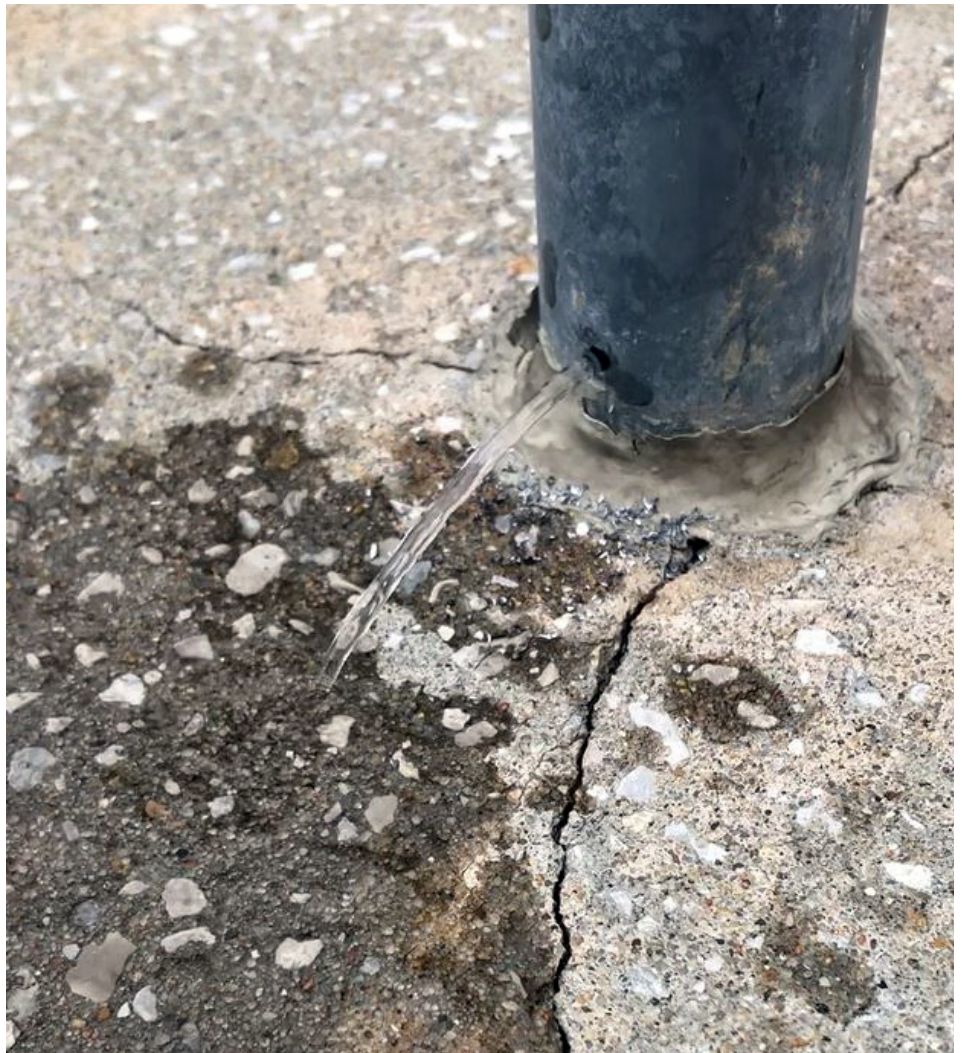
Figure 5.

is the most common source of moisture; however, an expansive reaction can even be triggered indoors by regular wet-cleaning of floors. On multiple projects, WJE has also documented liquid water within the full height of hollow steel and aluminum railing posts that acts as a gravity-fed reservoir (Figure 5) to feed the expansive chemical reaction.

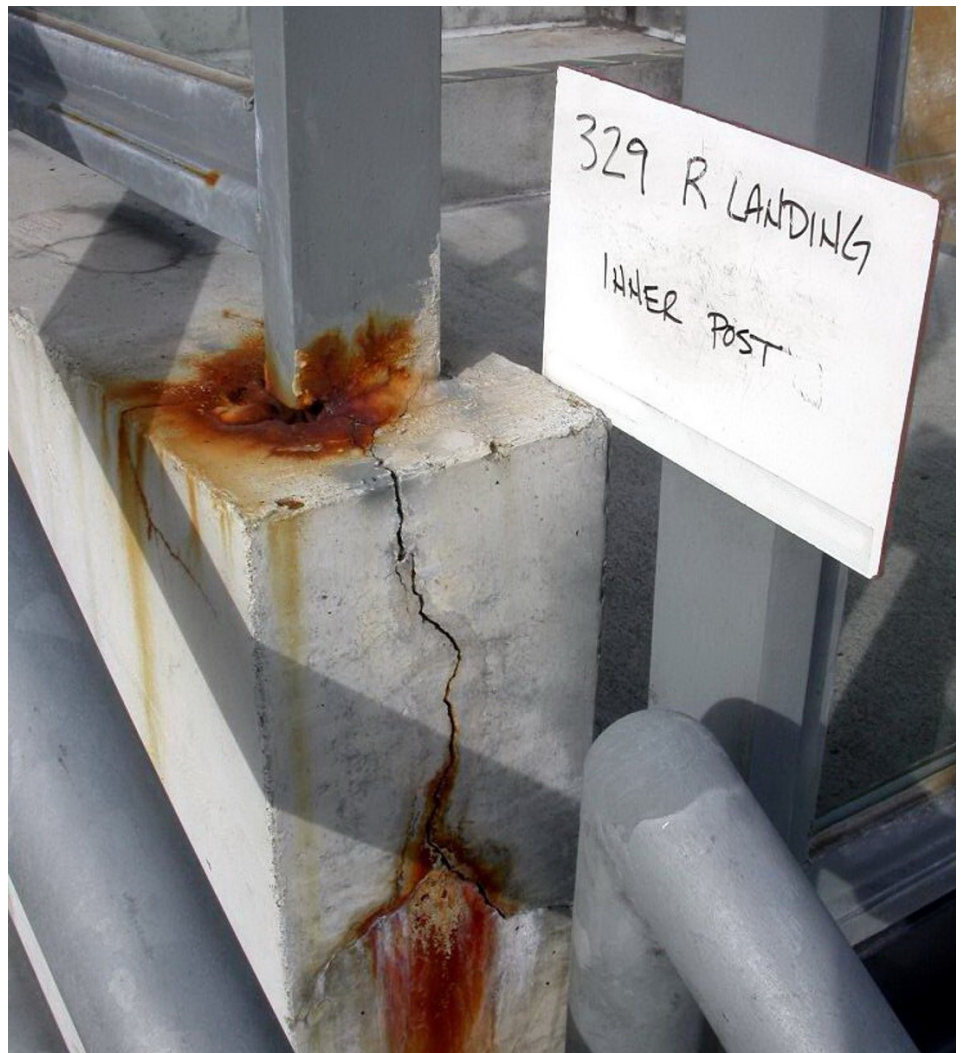
Figure 6.

in combination with gypsum's inherent porosity that creates a more damp environment, allows steel to corrode at a higher rate and more extensively (Figure 6). Corrosion of steel produces accumulation of rust scale, which also results in expansive forces within the grout pocket.
