Biogenic Sulfuric Acid Attack and Case Studies

by Hugh (Xiaoqiang) Hou, Kimberly A. Steiner, John Fraczek, and James A. Mahaney

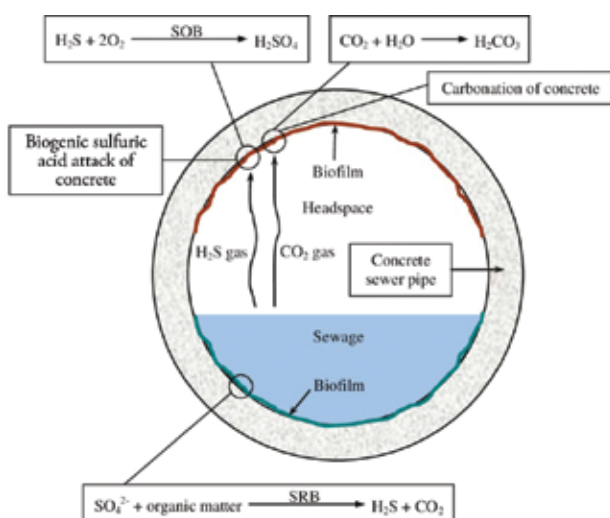
Fig. 1: Schematic representation of biogenic sulfuric acid attack (BSA) mechanism in a concrete sewer pipe (after Reference 2), where SOB is sulfur-oxidizing bacteria and SRB is sulfur-reducing bacteria. Elemental sulfur can be formed via chemical reaction: $2 H_2S$ (gas) + O_2 (gas) \rightarrow $2 S$ (solid) + $2 H_2O$ (liquid)

BSA involves cycling different sulfur species (of various valence) and eventually concentrating sulfuric acid on the concrete surface of sewer systems, waste digesters, chimneys, or similar structures, under the influence of various bacteria (Fig. 1). Normal sewage effluents have a pH of 5 to 8, which is not low enough to severely degrade concrete in contact.³ However, anaerobic bacteria (for example, *Desulfovibrio* species) in the sewer system can decompose inorganic and organic sulfur compounds (for example, sulfate), releasing hydrogen sulfide (H_2S) gas to the headspace above the effluent/sludge waste. The hydrogen sulfide is absorbed into a surficial moisture film on inner walls of concrete pipes, which contain aerobic bacteria such as thiobacilli. Hydrogen sulfide is oxidized into sulfur and eventually into sulfuric acid by bacterial metabolism. The sulfuric acid reacts with the cementitious paste of concrete (as well as steel and carbonate aggregate, if present) and causes deterioration.

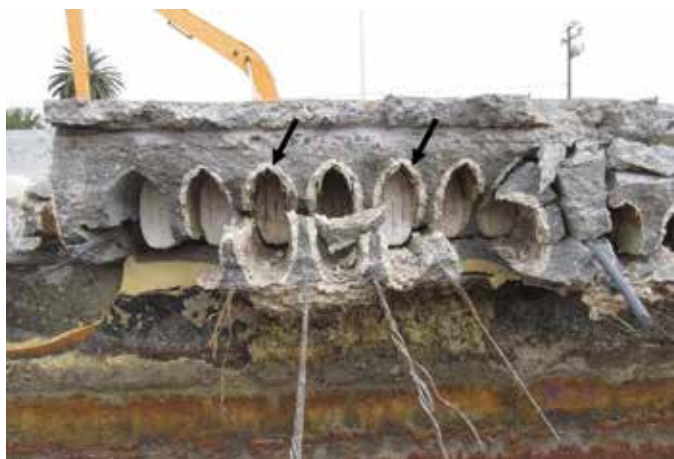
Fig. 2: Fractured concrete roof panel. BSA-caused deterioration manifested as paste color lightening and weakening along the cell perimeter (arrows) as well as corroded and broken prestressing strands

The concrete roof of a methane production facility failed prematurely because of BSA-caused corrosion. The roof consisted of a topping slab supported on hollow-core precast prestressed concrete planks. The concrete planks were apparently manufactured using an extrusion fabrication method, resulting in large amounts of irregular, interconnected, entrapped air voids in the concrete. Field investigation revealed that the plank concrete suffered severe deterioration throughout the roof area, with up to 5 in. (127 mm) of localized spalling from the underside and with broken or corroded prestressing strands (Fig. 2).

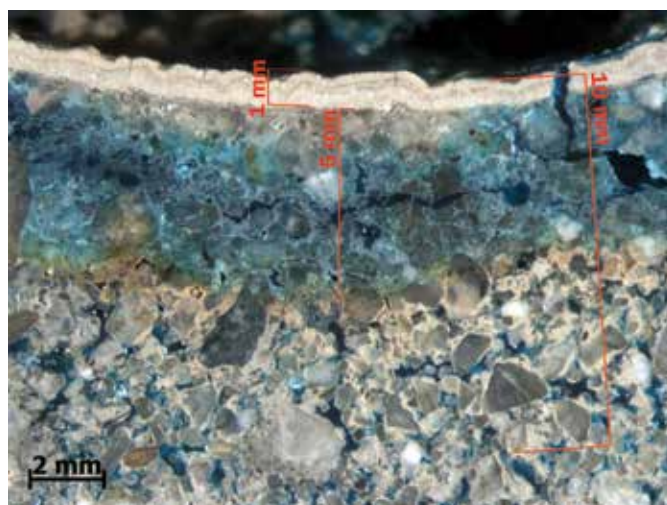
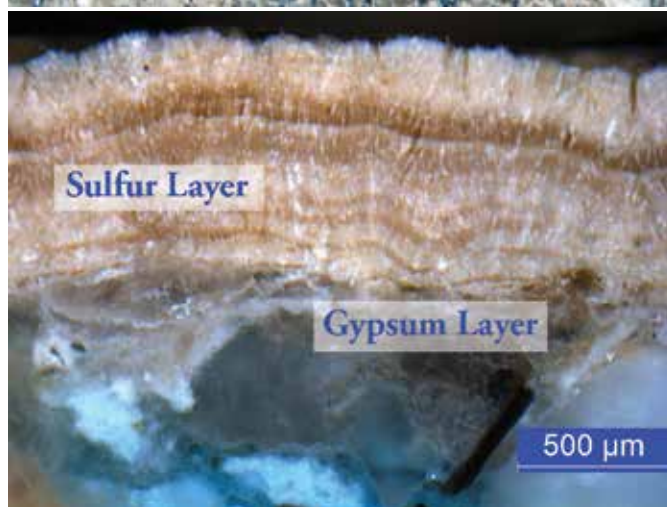
Fig. 3: Close-up views of near-surface concrete subjected to BSA with a banded sulfur layer (buff or pale white); a porous, weak, heavily paste-depleted zone; a brown carbonated front; and sound concrete. Blue epoxy applied in sample preparation readily soaked into the porous altered paste but not much into the dense, unaffected concrete except for large voids (Note: Different lighting condition and greater magnification for the bottom photo)

Concrete cores extracted from the top surface to the mid-depth of the planks (that is, the upper half of the planks) were studied using petrographic methods. The plank concrete exhibited distinct deterioration along the perimeter of the empty cells (cores) to a maximum depth of about 20 mm (0.8 in.), shown in Fig. 2 to 6. The deterioration appeared to be progressive, starting from the cell surface and propagating to the interior web and flange concrete to the side and above each cell. No deterioration or alteration of the concrete matrix was observed in the topping concrete.

- An elemental sulfur (S) layer, approximately 1 mm (0.04 in. or 40 mils) thick, at the perimeter of the cell (Fig. 3 and 4). The layer comprised many thin sublayers and exhibited an overall banded or lamination texture. Acicular sulfur crystals occurred and aligned perpendicular to the banding or the cell surface. Generally, no cement paste or aggregate particles were present in the sulfur layer. The layer did not appear to have been derived or altered from concrete or exhibit evidence of concrete constituents. The

- Large, frequently tabular euhedral gypsum crystals behind the sulfur layer. The thickness of the large gypsum zone was approximately 0.2 mm (8 mils), shown in Fig. 3 and 4. Only a few aggregate particles were present in the gypsum layer. Large euhedral gypsum crystals are presumed to have recrystallized from solution, and the presence of the large crystals (as well as the sulfur layer described previously) would indicate a long period of a stagnant, nonturbulent environment;
- A zone behind the large gypsum layer of intimately mixed microcrystalline gypsum and amorphous silica-alumina gel that encased aggregate particles. The thickness of this

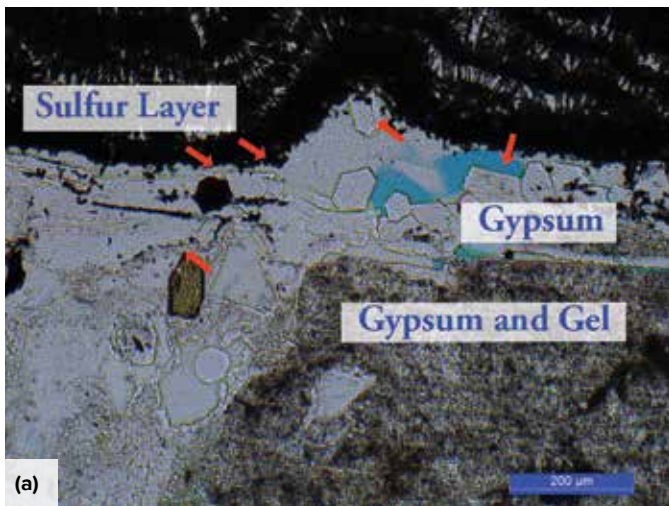
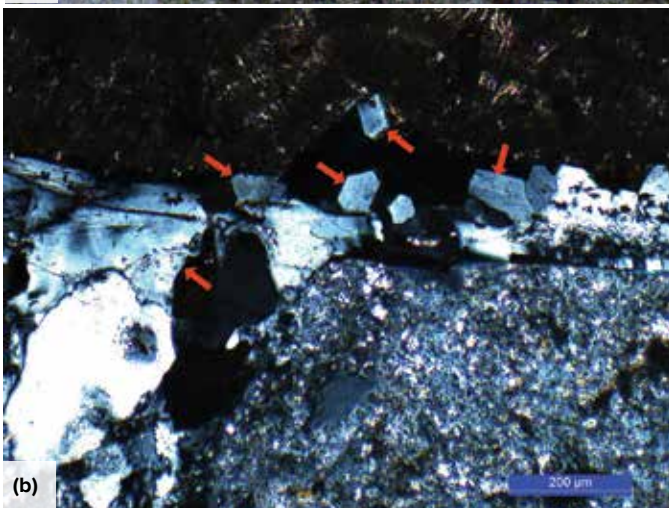
Fig. 4: Thin-section photographs show a sulfur layer (black) backed by large euhedral tabular gypsum (red arrows), and a microcrystalline gypsum and silica gel zone: (a) plane-polarized light; and (b) cross-polarized light

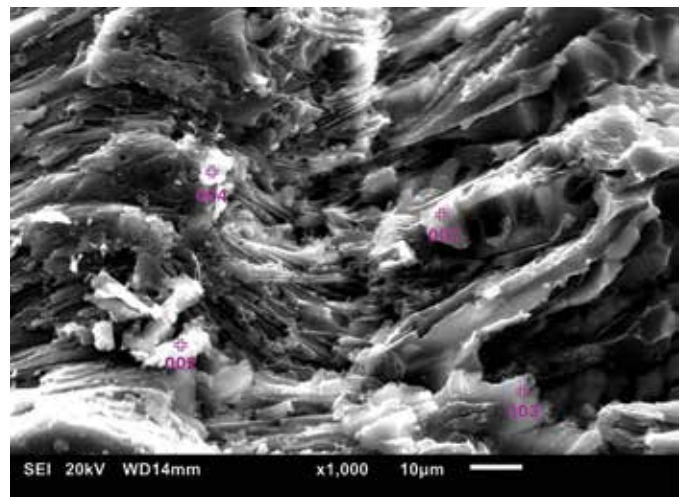
Fig. 5: Secondary electron image (SEI) of sulfur deposit on BSA-affected plank concrete. The composition of the deposit was confirmed using energy dispersive X-ray spectroscopy

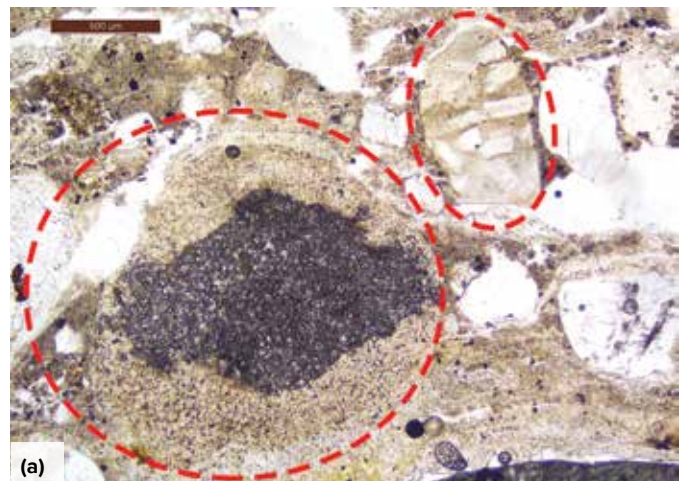
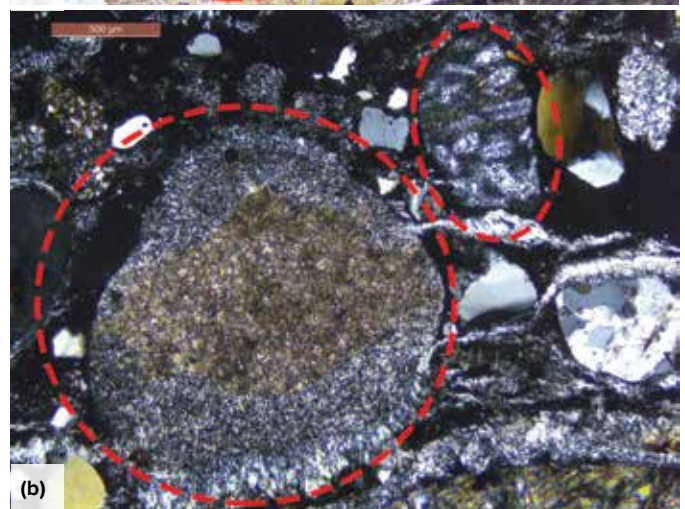
Fig. 6: Thin-section photo shows two carbonate sand particles (circled) partially replaced by gypsum: (a) plane-polarized light; and (b) cross-polarized light. Quartz/quartzite and other siliceous particles were not chemically affected by the acid attack but could frequently exhibit cracks lined with gypsum

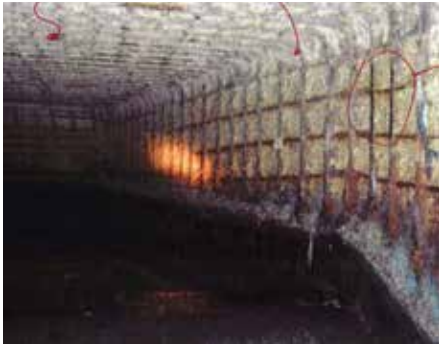
Fig. 7: Sewer tunnel with exposed second mat of steel reinforcement. Top concrete and the first mat of steel reinforcement were reportedly lost to the existing surface (from Reference 7)

Concrete from a 100-year-old buried tunnel structure exhibited severe discoloration, spalling, and steel reinforcement corrosion. The interior surface of the tunnel showed a severely corroded reinforcement mat, reportedly the second layer of reinforcement (Fig. 7). Cored concrete studied in the laboratory exhibited overall compositional and textural characteristics similar to those discussed in Case Study I (Fig. 11 and 12 from Reference 7), except that the elemental sulfur layer was not observed. The BSA-affected layers were thin, typically about 0.2 in. in total thickness. Concrete in the exterior of the structure appeared to be in good condition and did not exhibit BSA-related or other distress. The tunnel concrete appeared to have been

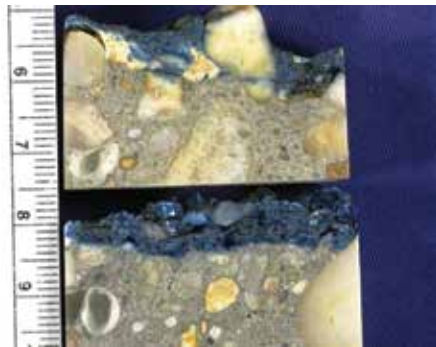
Fig. 8: Close-up views of the near-surface region of the tunnel concrete. The depth of affected paste is well defined by the visible change in color and appearance of the degraded cement paste. Blue epoxy readily soaked into the porous off-white or pale-yellow altered paste but not into the dense, unaffected body concrete. Scale is in millimeters

batched with a low w/c that resulted in hard and dense paste (Fig. 8).
