## PROJECT PROFILE

# Plaza Deck Collapse Investigation

Post-Tension Slab Failure | Stamford, CT

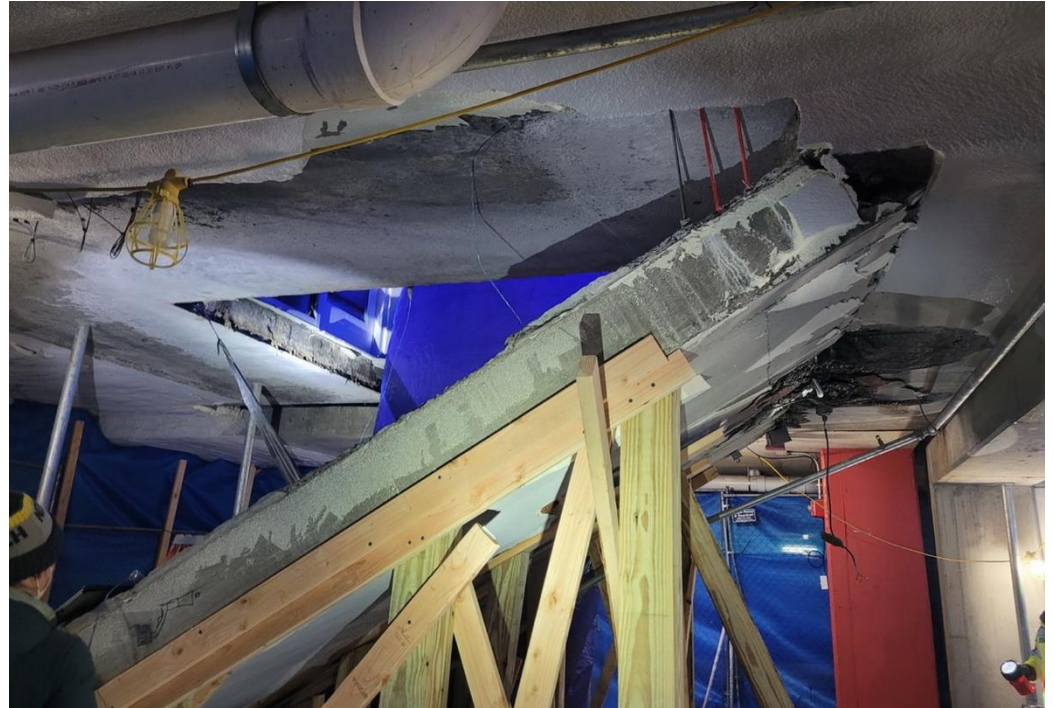
A partial collapse of the fifth-floor terrace post-tension slab occurred in February 2022. The client engaged WJE to investigate the cause of the collapse and to determine if other buildings in Stamford—built with a similar structural system by the same developer and engineer—could have similar issues.

WJE was on site the day after the collapse to document the in-situ condition of the collapsed slab. We performed nondestructive testing and took material samples of the concrete, post-tensioning, and reinforcement. We then performed a detailed review of all design documents, shop drawings, and special inspections from the original construction. Following our review, we issued a report indicating the cause of the collapse. In addition, we performed a peer review of the repair design and performed construction period services for the repair on their behalf. Following the repair of the Allure, we visually inspected an additional four buildings developed by the same team utilizing a similar construction type and provided recommendations for repairs for further investigation by the developer.
