# Andersen Air Force Base Water Tank

Water Tank Roof Collapse | Yigo, Guam

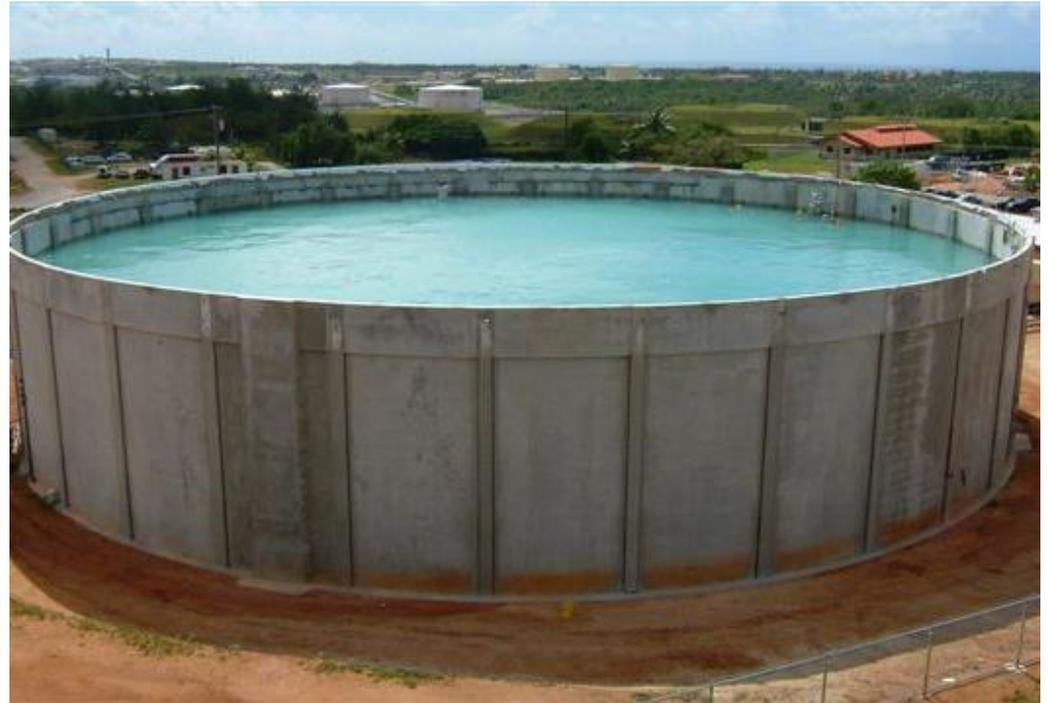
The Andersen Air Force Base water reservoir was designed to replace the off-base water supply for the base. The cylindrical tank was designed to hold 12,320 kiloliters of water. The steel-reinforced concrete reservoir was completed in January of 2007. The roof of the concrete reservoir was cast-in place while the walls were made up of twenty-eight precast and prestressed sections.

On July 12, 2007, the roof of the water tank supposedly collapsed. During that time, the reservoir was being filled for the second time after the completion of construction. WJE was retained to determine the reason for the roof collapse and also if the tank could be salvaged for future use.

WJE determined that the roof collapse of the water tank was the result of negative differential pressures on the roof of the tank while water was being pumped out of the tank. The tank had been constructed without vents, and as a result, the pressure equilibrium within the tank could not be maintained. After a structural and materials assessment, WJE determined that the existing concrete walls and base of the structure could continue being used.
