PROJECT PROFILE

Bridge of the Americas

In-Depth Condition Assessment | Panama Canal, Panama

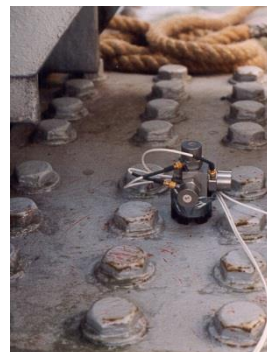
The engineers then installed strain and deflection gages to measure static strains and deflections due to a heavily loaded test truck and to temperature changes and also to obtain vibration data from the test truck driving over an obstacle. The suspension cables were tested to determine cable tensions, to capture vibration data for each suspension cable, and to measure frequency response spectra, which were found to correspond to each cable's characteristic frequencies of vibration. Using the spectrum data, WJE calculated suspension cable loads and presented recommendations for the repair and protection of the concrete deck.
