PROJECT PROFILE

Castlewood Canyon Bridge

Historic Restoration and Structural Repair | Castle Rock, CO

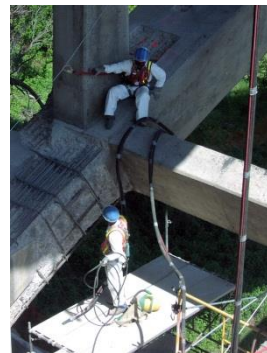
The bridge had sustained extensive deterioration of the concrete and reinforcing steel as a result of chronic, long-term exposure to moisture and deicing salts. Repair required the removal of unsound concrete behind the reinforcing steel for substantial distances along the lengths of the arches, potentially weakening the affected members during construction. Repairs were further complicated by a requirement to keep the bridge open for limited public traffic during repairs and the need to support heavy construction equipment, such as cranes and concrete trucks.

WJE performed structural analyses of the arches and determined critical dimensional limitations for staged demolition and repair. Based on these results, recommendations were provided for staggering and sequencing the work in a manner that would maintain the structural integrity of the bridge while safely supporting the required traffic and construction loads. During construction, WJE developed supplemental field modification details to address conditions encountered as the repair work progressed.
