PROJECT PROFILE

St. Vincent Ruth Lilly Center

Stone Displacement Investigation at Stair Tower | Indianapolis, IN

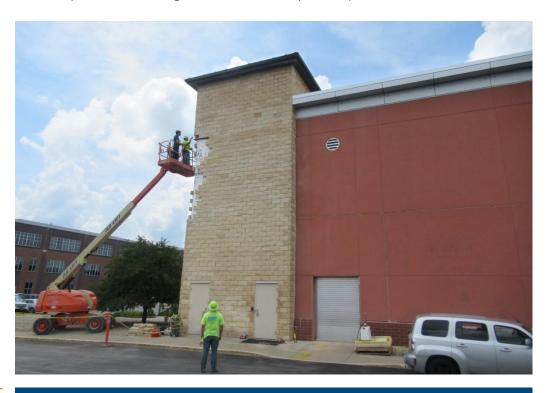
During the construction of the addition to the building, the general contractor observed displaced stone units at the southeast stair tower. Ascension Health engaged WJE's services to investigate the cause of the displaced stone and develop repair recommendations.

Based on WJE's observations, the displaced stone masonry was likely related to thermal- and moisture-related expansion and contraction of the stone cladding in two different directions at a corner. Based on WJE's document review, the expansion joints to accommodate expansion and contraction of the stone cladding were included in the original design documents; however, there was no evidence that the expansion joints were ever constructed in the wall.

WJE recommended removal and reinstallation of the displaced stone; installation of expansion joints through the thickness of the stone at locations consistent with the original drawings; and installation of anchors within eight inches of the corner, where rebuilt. In addition, WJE recommended repointing deteriorated and cracked mortar joints with a mortar compatible with the existing stone.
