Concrete Rehabilitation Design for the Historic 3rd Avenue Bridge, Minneapolis, Minnesota

by Arne Johnson, Tanner Swenson, Dan Enser

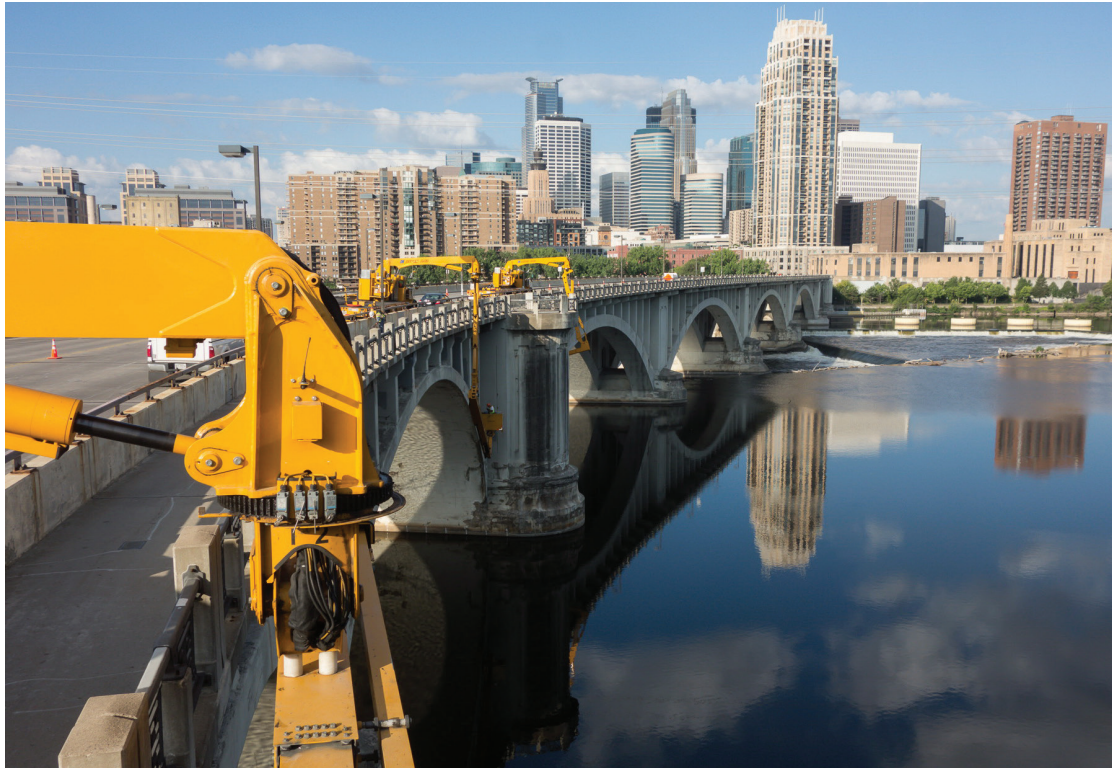
Fig. 1: Engineers utilizing three under bridge inspection units for close-up bridge inspection and sounding during the Phase 1 bridge inspection (photograph by WJE).

The condition assessment for the 3rd Avenue Bridge was performed in two phases. Phase 1 consisted of a close-up, element-level bridge inspection and sounding of 100% of the exposed surfaces (Figure 1). Distress conditions and condition states (according to MnDOT standards) were digitally mapped on scaled drawings using WJE's in-house iOS-based tablet software. Each inspector carried a tablet pre-populated with base sheets and custom drop-down fields that allow every condition to be digitally described and recorded. The data are accessible simultaneously by all the inspectors in the field as well as in the future by any individual with sign-in credentials. The software also has powerful post-processing capabilities including direct download into Excel or CAD, which immediately provides unlimited sorting and searching capabilities, as well as quantity calculations.

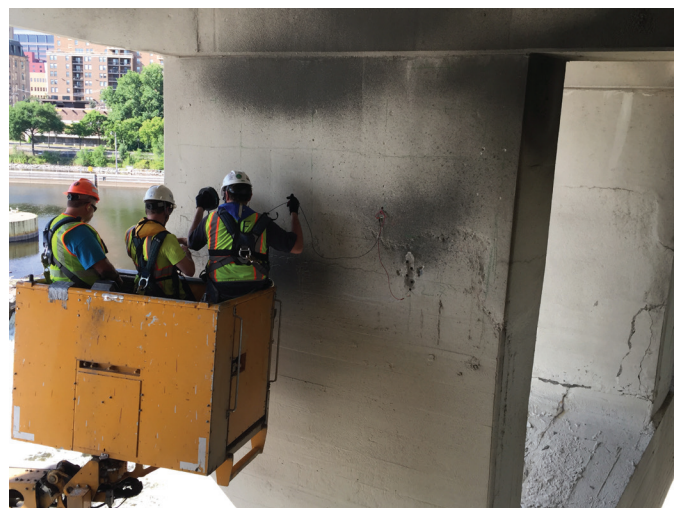
Field testing methods utilized on the 3rd Avenue Bridge included half-cell potential surveys, corrosion rate measurements, resistivity testing, carbonation testing, and ultrasonic thickness testing of steel truss members (Figure 2). Lab testing of material samples taken from the bridge included testing for mechanical properties of concrete and steel materials, chloride content analysis and chloride horizon profiling (particularly important for the deck and substructure elements below deck joints), and petrographic analyses of numerous cores to identify vulnerabilities specific to the concrete in this structure (i.e., freeze-thaw cracking, air content, carbonation depth, paste-aggregate characteristics, etc.). Service life projections were developed for each element type utilizing the test data that were collected, and this information was used to inform the development of rehabilitation alternatives and life cycle cost comparisons.

Fig. 2: Engineers utilizing three under-bridge inspection units for close-up bridge inspection and sounding during the Phase 1 bridge inspection (photograph by WJE).

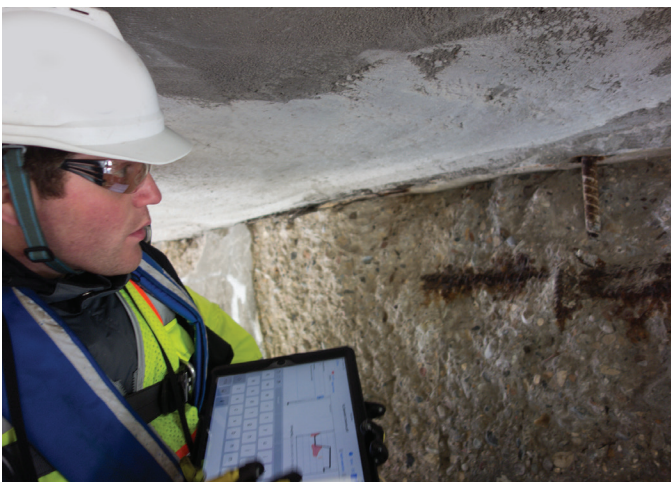
One of the biggest challenges in repairing historic concrete is accurately estimating and controlling the repair quantities. For the 3rd Avenue Bridge project, quantities were estimated by leveraging the inspection software described above to calculate the as-mapped areas that warranted a repair (Figure 3). Three factors were then applied to convert the as-mapped quantities into quantities for the repair plans: a squaring off factor (converting as-mapped areas to rectilinear shapes), a time delay factor, and an “other factor” intended to capture some of the typical unknowns in repairing aging concrete. In all, the total repair factor, sometimes called the growth factor, ranged from 1.8 to 2.2 for the various bridge elements. This is consistent with the authors’ experience on similar previous projects.

Fig. 3: Bridge inspector recording notes utilizing proprietary iOS-based tablet inspection software (photograph by WJE)

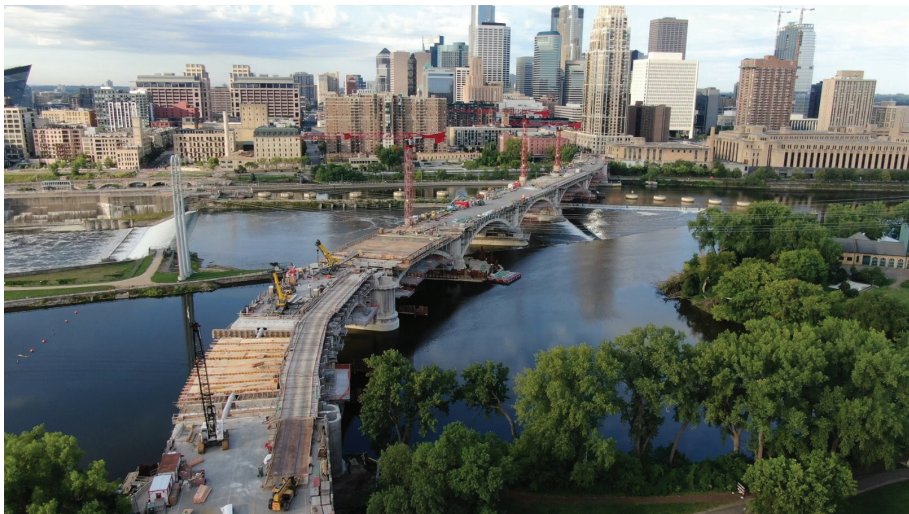
Fig. 9: Recent drone image showing status of the in-progress construction (photograph by WJE)

Construction is underway under a full bridge closure and an aggressive schedule (Figure 9). Once rehabilitation is complete, the lessons learned from execution of the concrete repairs will be shared.
