# 1660 International Drive

Exterior Wall Water Leakage Investigation and Repair Design | McLean, VA

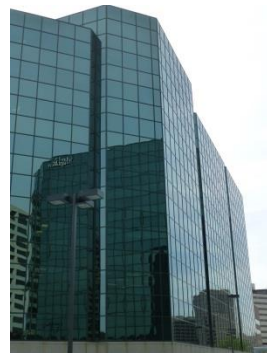
WJE was retained to investigate and develop repair drawings and technical specifications to address uncontrolled rainwater penetration through the glazed aluminum curtain walls. The client had previously received another consultant's repair recommendations based on a limited visual investigation but retained WJE to complete a more detailed and comprehensive evaluation of the property through water penetration testing and close-range visual observations.

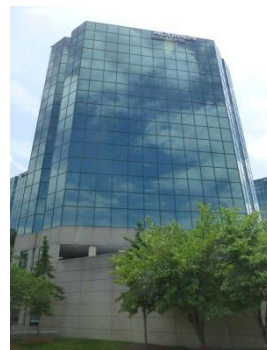
WJE conducted a close-range, exterior visual condition assessment of representative samples of the glazed aluminum curtain wall and precast concrete wall panels below. The investigation included field testing for water penetration resistance at numerous locations throughout the property. As a result of this investigation, WJE determined that water leakage was attributed to the inability of the curtain wall assembly to properly manage water internally due to missing or defective interior end-dams and joint plugs. To solve this problem, WJE developed repair documents to competitively bid building-wide conversion of the drained curtain wall assembly to a barrier system. WJE's repair design and implementation addressed the uncontrolled rainwater penetration while remaining within the client's project budget.
