PROJECT PROFILE

Planet Fitness

Water Leakage Investigation and Repair Design | Frankfort, KY

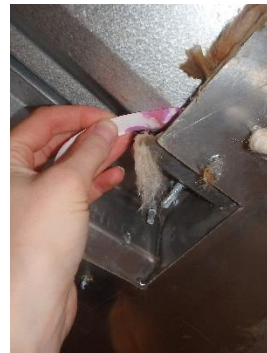
WJE performed water testing of suspect conditions to investigate the probable sources of water infiltration. Water testing was performed using systematic procedures to isolate the sources of leakage. Based on the observed conditions and water testing results, WJE determined that the likely sources of water infiltration were related to seals between the roofing panel laps and standing seams.

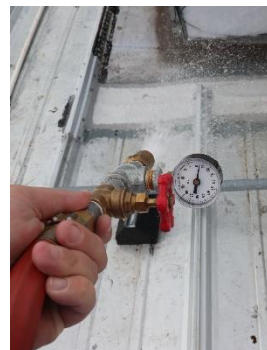
Based on the results of the investigation, WJE recommended trial repair concepts that utilized preformed silicone seals and prefabricated standing seam repair caps to address the sources of leakage. Trial repairs were implemented at confirmed sources of water infiltration and tested by WJE to confirm the effectiveness of the repairs prior to full implementation.
