Planning for new building projects should consider the impacts of demolition, excavation, dewatering, and construction on adjacent buildings.

Wiss, Janney, Elstner Associates, Inc.

An Overview of Risks in Adjacent Demolition and Construction

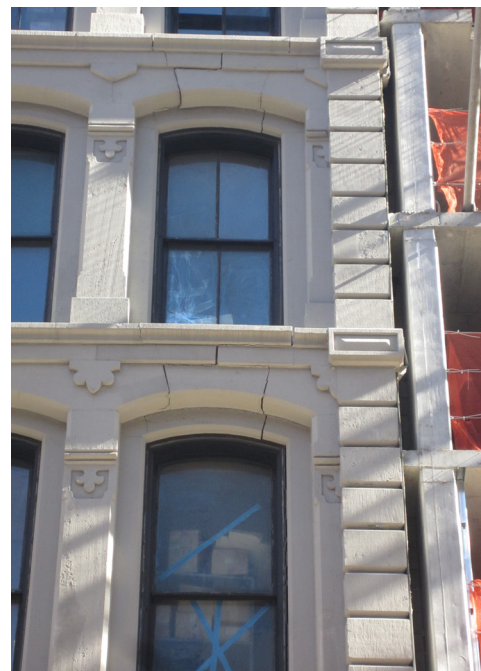
Figure 1. Cracking and displacement of existing stone arches due to foundation settlement associated with adjacent construction. New floor slabs also extend into a required seismic gap, where they can apply damaging earthquake loads to the existing building.

Superstructure Construction: The risks of adjacent building movement and damage due to foundation settlement or lateral displacement may decrease once the new building's foundation walls are braced by the permanent structure of the first floor, allowing monitoring to be reduced or discontinued. However, it may be prudent to continue some monitoring until after the new building is "topped out," as the increasing dead load on its foundations may cause additional settlement of soil supporting the foundations of adjacent buildings. Building code may also require horizontal separations, also called seismic

gaps, to allow new and existing buildings to displace independently in response to wind and earthquake forces without impacting each other or transferring loads between lateral force-resisting systems. Required separations may be filled with compressible material but should be clear of rigid protrusions that reduce their width. As in the demolition phase, the need to protect lower roof surfaces and adjacent areas from falling material should be considered.

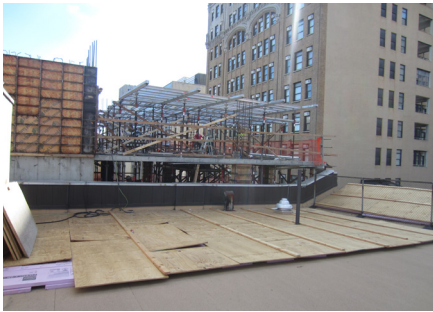
Figure 2. Inadequately secured sheets of plywood, intended for roof protection, can be dislodged by wind. This city's building code requires the plywood to be fastened over a layer of scaffold plank.

The property owner and design team for the new building should be aware of the vulnerabilities of existing buildings and minimum building code requirements for protection of adjacent properties (Figure 2). Experienced consultants and knowledgeable attorneys can help inform existing building owners about their rights to protection and their duties to provide access for installing monitoring and protection measures. These rights and duties are established in the building code and can be further defined through legal contracts such as a license or access agreement between adjacent property

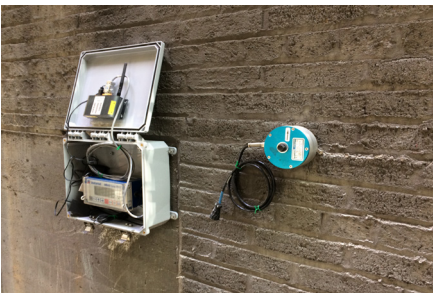
Figure 3. Installation of seismograph (at right) and monitoring data logger (at left) in progress at foundation wall of existing building.

Preparation: Before starting work, monitoring of background (ambient) vibrations, pre-construction condition assessments of existing buildings, installation of crack width gauges or monitors, and optical surveying or laser scanning can identify vulnerabilities and set a baseline for evaluation of any subsequent reports of adjacent building movement or damage. Some building codes include limits on building movement and vibration. For existing buildings of exceptional sensitivity or significance, preemptive stabilization or bracing, temporary removal of fragile contents, or lower-than-typical movement and vibration limits may be appropriate.² Access should be arranged for installing monitoring and protection measures before work begins (Figure 3).

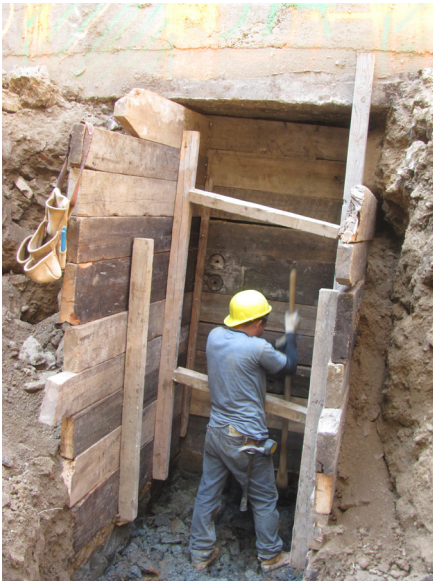
Figure 4. Timber sheeting at underpinning approach pit with adjacent areas improperly excavated alongside the existing foundation, increasing the risk of soil movement.

Excavation and Foundations: Removal of soil from beneath an existing foundation (undermining) is generally unacceptable, except in controlled underpinning operations. Excavating vertically downward alongside an existing foundation (Figure 4) should also be avoided, as it removes lateral support provided by the soil beneath or adjacent to the foundation, which may slide downward or buckle outward into the excavation. Excavation support systems (e.g., sequential underpinning with concrete piers, soldier piles with timber lagging, secant piles, and soil berms or benches) and associated dewatering schemes should be selected to keep vertical and lateral soil movement within acceptable limits. Equipment for installing excavation support systems, drilling or driving deep foundation elements, and removing rock should be selected to prevent excessive vibrations from damaging adjacent buildings. Water management measures should be considered to prevent precipitation, groundwater, drilling fluids, and water leaking from utility lines from infiltrating through foundation walls of adjacent buildings, promoting settlement of supporting soil, or causing erosion of soil berms or benches within the excavation.

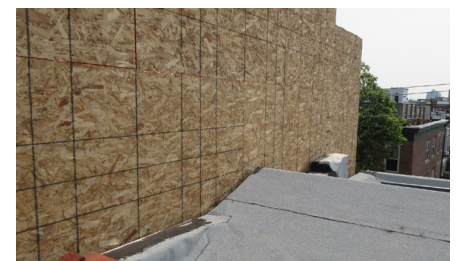
Figure 5. This interface between a rising wall and an existing roof will require careful detailing to exclude water. Any active chimney flues will also need to be extended above the new, higher roof line.

Building Interfaces: Vertical and skyward-facing interfaces between new and existing buildings should be detailed to exclude water and vermin. Where the new building rises above adjacent buildings, existing roof drainage systems should be evaluated for additional flow from precipitation running down rising walls onto lower roof surfaces (Figure 5). Existing roof structures should be evaluated for the additional weight of snow sliding from higher roof surfaces or forming drifts against rising walls. The need for extending or redirecting existing chimney flues, exhaust ducts, plumbing vents, fire escapes, means of egress, and similar items should also be evaluated. Openings in walls covered by the new building typically require infill; fire resistance considerations may apply to the detailing of infill or to the protection of existing openings in adjacent walls.

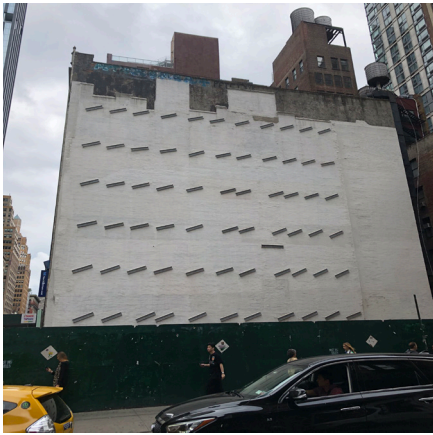
Figure 6. Former shared wall following demolition of existing building, with short lengths of steel channel attached to anchors bracing the masonry to floor structure at each level.

Party walls, also known as shared walls, are located along property lines and provide support shared by the buildings on either side. If the building on one side is demolished, the party wall must be maintained in good condition to provide continuing support to the adjacent building (Figure 6). Responsibilities related to party walls may be defined in the building code, property easements, and/or access agreements.

Bracing and waterproofing are typically recommended when existing party walls are exposed, especially if the new building is structurally independent and separated from adjacent buildings. If a former party wall is not properly anchored to the remaining floor and roof joists after the corresponding joists are removed from the opposite side, it could buckle into the gap between the buildings and/or collapse. While it may be less disruptive to install joist-to-wall anchors from the exposed face of a former party wall, they can also be installed from the interior, even after the exposed face is obstructed by the new building. Connections between front and rear facades and exposed party walls should also be reviewed and reinforced if necessary. If waterproofing of the exposed face is either temporary or omitted, it will be particularly critical to ensure that interfaces between new and existing buildings are properly sealed in accordance with details developed and reviewed by qualified design professionals.
